STREET(E)SCAPE: A Site-Specific and Contextual Approach in Documentation, Design Interventions, Cultural Mapping and Conservation of Sta. Catalina, Carcar, Cebu

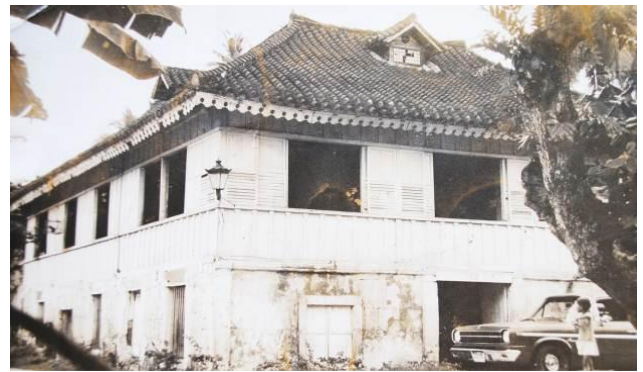
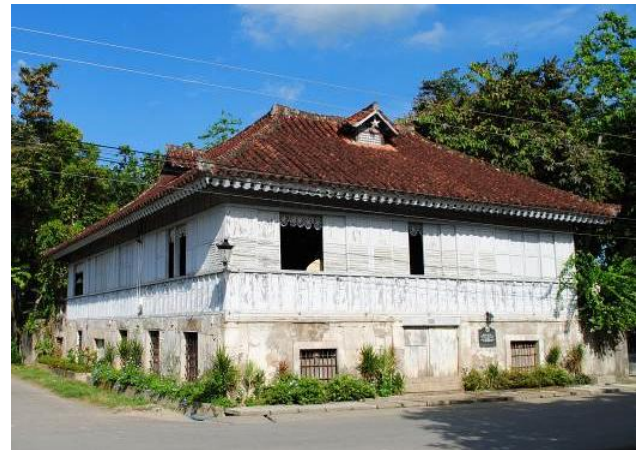
Figures 8 and 9. Old and new photos of Balay na Tisa. The rise of the street level from the old times is apparent. Source: from private collection of Jerry Martin Noel Alfafara (old photo above)

road has left the house foundation and ground floor level already 0.70 meters below the street. Another serious issue confronting *Balay na Tisa* was the deterioration of wooden structural and finishing components, especially in the kitchen area and inside the rooms; in contrast to the living room, the dining room and the *ante sala* areas that remained relatively stable. Pulverization was also observed in the stone foundations, probably brought about by natural ageing.

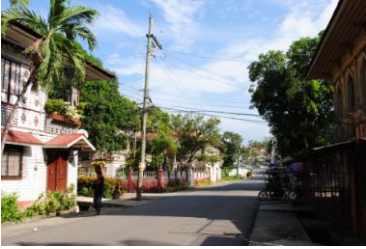
<p>Photo 1: View of the first intersection facing Rizal St. <i>Note: very nice vistas and views available in this intersection due to preserved houses and mix of textures and balance of trees and structures.</i></p>	<ol style="list-style-type: none"> Three notable ancestral houses marked the intersection (highest concentration of ancestral houses in the whole Sta. Catalina Street) Residential character but commercial activities encroaching Visual axis to the Plaza Mayor still evident Architectural character is preserved Utility poles are evident Various trees soften the edges Absence of sidewalk Clean surrounding Gates and fences are introduced Pedicabs are available along the street 	Weak	Strong	Strong	Strong	Strong	Strong	Strong	Strong	Strong	Strong	Strong	Strong

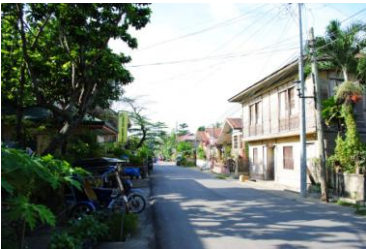
<p>Photo 2: Street view showing Dr. Cui House approaching Zamora St.</p>	<ol style="list-style-type: none"> Ancestral houses still present but in deteriorating conditions Mixed uses evident Smaller houses begin to appear Eclectic architectural character begins to emerge Smaller trees Absence of sidewalk Some residents extend their spaces on the street Commercial activities spill over the street Commercial signages are not consistent Utility poles are present Some open canals were covered to provide access to property 	Weak	Strong	Strong	Strong	Strong	Strong	Strong	Strong	Strong	Strong	Strong	Strong

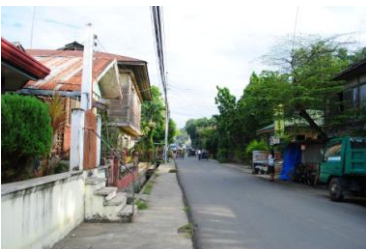
<p>Photo 3: View from Sta. Catalina St. showing responses to flooding</p>	<ol style="list-style-type: none"> Architectural elements (fences with stairs) in response to flooding are evident Dilapidated ancestral houses are present Some vehicles were parked along the street Utility lines are present Absence of sidewalk Some residents extend their spaces on the street Commercial activities spill over the street Most of canals were covered 	Weak	Strong	Strong	Strong	Strong	Strong	Strong	Strong	Strong	Strong	Strong	Strong

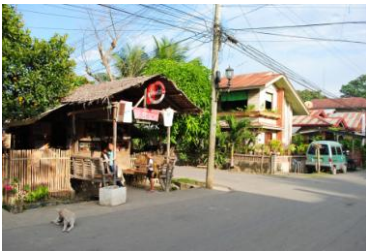
<p>Photo 1: View of the sari-sari store at the Zamora St. intersection</p>	<ol style="list-style-type: none"> Robust features on street, highest concentration of extended personal spaces on street Places of convergence for neighbors are present, i.e. sari-sari store. Sense of enclosure for house units evident Mixed architectural character Utility poles are evident Ancestral houses present in the corners Absence of sidewalk, obstructed Canals start to appear stagnant 	Weak	Strong	Weak	Strong	Weak	Strong	Weak	Strong	Weak	Strong	Weak	Strong

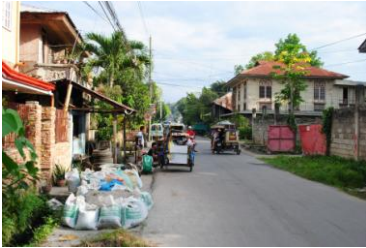
<p>Photo 2: Street view showing extended activities on street</p>	<ol style="list-style-type: none"> Ancestral houses still present but deteriorating conditions Mixed uses evident Smaller houses begin to appear Mixed architectural character Smaller trees Absence of sidewalk Some residents extend their spaces on the street Commercial activities spill over the street Commercial signages are not consistent Utility poles are present Some open canals were covered to provide access Unmaintained grass growth along the street 	Weak	Strong	Weak	Strong	Weak	Strong	Weak	Strong	Weak	Strong	Weak	Strong

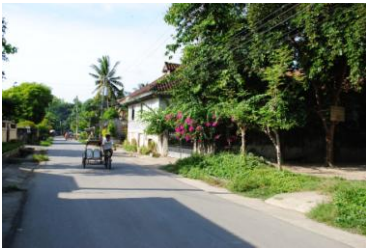
<p>Photo 3: View approaching the Balai na Tisa</p>	<ol style="list-style-type: none"> Balai na Tisa as landmark of Architectural Heritage Street, in well maintained condition (the last ancestral house along Sta. Catalina) Utility lines are present Absence of sidewalk Blank lot beside Balai na Tisa used as basketball court Big trees present Residential character Some open canals were covered to provide access 	Weak	Strong	Weak	Strong	Weak	Strong	Weak	Strong	Weak	Strong	Weak	Strong

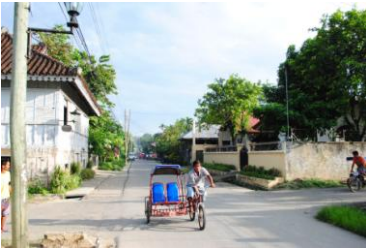
<p>Photo 1: Corner of the Sta. Catalina - Rosario St. (Balai na Tisa at the left side)</p>	<ol style="list-style-type: none"> Balai na Tisa marked the end of the line of ancestral houses along the street Residential character : vernacular Utility poles are evident Various trees soften the edges Absence of sidewalk Gates and fences are introduced Pedicabs station at the corner <p>Note: <i>linear vista</i></p>	Strong	Weak	Weak	Weak	Weak	Weak	Weak	Weak	Weak	Weak	Weak	
			Average	Strong	Strong	Strong	Strong	Strong	Strong	Strong	Strong	Strong	Strong	Strong

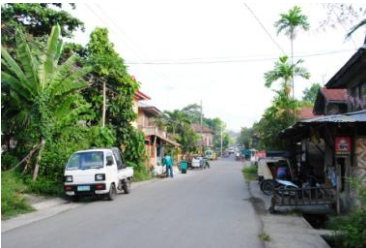
<p>Photo 2: General street view of Block 4</p>	<ol style="list-style-type: none"> Vernacular houses are prominent Mixed uses evident Neighborhood chapel present in this block Mixed architectural character Trees preserved Absence of sidewalk Some residents extend their spaces on the street Commercial activities spill over the street Canals appear stagnant Utility poles are present Some open canals were covered to provide access Some vehicles were parked along the street 	Strong	Weak	Weak	Weak	Weak	Weak	Weak	Weak	Weak	Weak	Weak	
			Average	Strong	Strong	Strong	Strong	Strong	Strong	Strong	Strong	Strong	Strong	Strong
			Weak	Weak	Weak	Weak	Weak	Weak	Weak	Weak	Weak	Weak	Weak	Weak

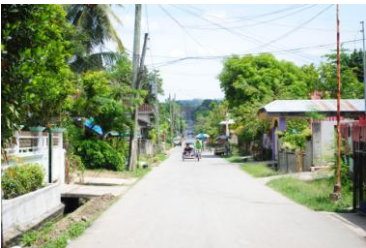
<p>Photo 3: Axial view of Sta. Catalina St. (from end of street)</p>	<ol style="list-style-type: none"> Typical residential streetscape Utility lines are present Absence of sidewalk Robust features especially in front of sari-sari stores Some residents extend their spaces on the street Lot cuts are smaller Fenced frontages Curved street end creates momentum in movement 	Strong	Weak	Weak	Weak	Weak	Weak	Weak	Weak	Weak	Weak	Weak

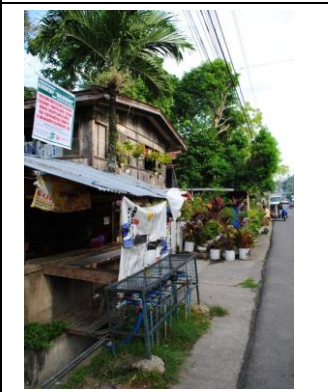
6. Street Utilities

Some street drainage canals are left open, some are covered with concrete slabs, and some are completely covered with concrete or access to property. Water at canal is stagnant (slow flow). Water meters jut out of the properties onto the "sidewalks". Utility electrical posts are present.	Canals are clogged with garbage; they are of poor capacity due to outdated size. Poorly maintained utility posts are fire hazards.	<ol style="list-style-type: none"> 1. Promote cleaning and declogging of the canals. Cover the canal and make its surface part of the sidewalk development. 2. Increase the capacity of the street canal to lessen threat of flooding. 3. Revive the fire hydrants along the street. 4. Wirings and other cables must be thoroughly checked and be properly bundled to alleviate visual clutter.
