COMPARISON OF LIQUEFACTION-INDUCED DAMAGE OBSERVED DURING THE 2011 CHRISTCHURCH (NEW ZEALAND) AND 1990 LUZON (PHILIPPINES) EARTHQUAKES

Rolando P. Orense, Dr. Eng, P.E.
Department of Civil & Environmental Engineering
University of Auckland
Auckland, New Zealand

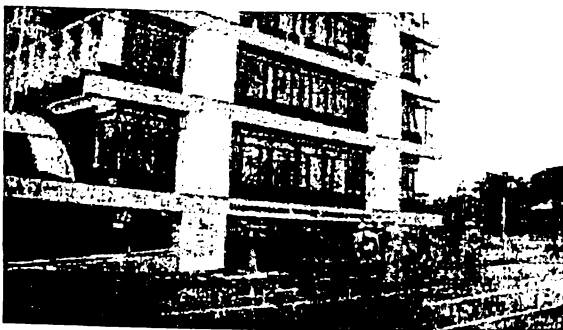
Liquefaction and lateral spreading were extensive in areas adjacent to Avon River, which follows a meandering course through Christchurch from its source in the west through the CBD. Many buildings, such as the 5-storey Trade Centre Building in the CBD shown in Figure 4(a), sank and tilted as a result of the loss in bearing capacity of the foundation ground. Geotechnical investigations indicated that virtually all buildings in the central business district are on shallow foundations, with a several high-rise structures, such as the Forsyth Barr and Price Waterhouse buildings, are on of Colombo are on raft foundations (McCahon 2011). All this area is underlain with shallow gravel to 8 – 10m depth, over sand (dense to very dense) below 12 – 15m and then first gravel aquifer at 22 – 23m. Outside this area, the gravel disappears and many larger and more recent buildings are supported by pile foundations. Ground conditions are highly variable and there is shallow gravel in places with shallow foundations.

Figure 4. Settlement of reinforced concrete buildings:
(a) 2011 Christchurch Earthquake; and (b) 1990 Luzon Earthquake.

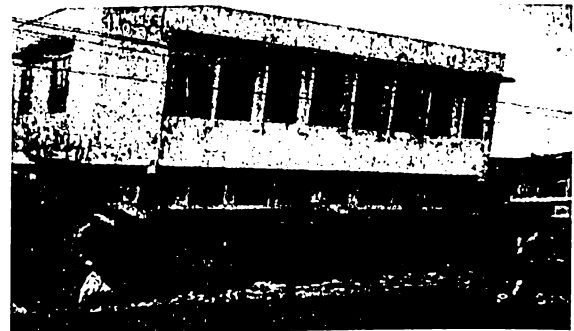
(b)

In Dagupan City, close to around 500 buildings and residential houses underwent severe settlements (Figure 4b), as well as varying amounts of tilting (Figure 5b), as a result of the loss in strength of the underlying soil. Except for one, no building in the affected area was supported by piles, and therefore, no resistance was possible against subsidence after liquefaction. Ironically, earthquake shaking did not destroy buildings in the area nor caused any structural damage.

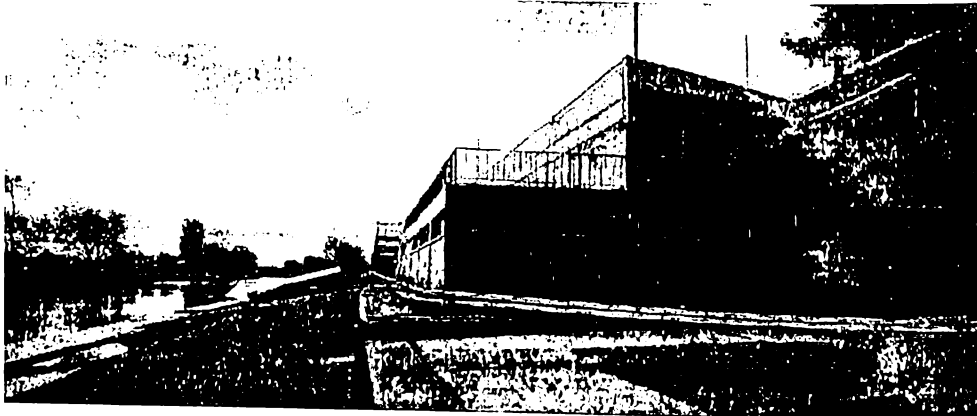
Lateral spreading associated with soil liquefaction resulted in large permanent lateral displacements in the order of 1-3.5 m in many areas, with large ground cracks of about 0.5-1.5 m wide running through residential properties. The Avon Rowing Club building, shown in Figure 6(a), underwent severe damage due to large lateral ground movements towards the river. Along Bassett Road, the abutment of a bridge tilted (Figure 7a) as a result of liquefaction-induced lateral spreading.

Figure 6. Damage to structures due to lateral spreading: (a) 2011 Christchurch Earthquake; and (b) 1990 Luzon Earthquake.

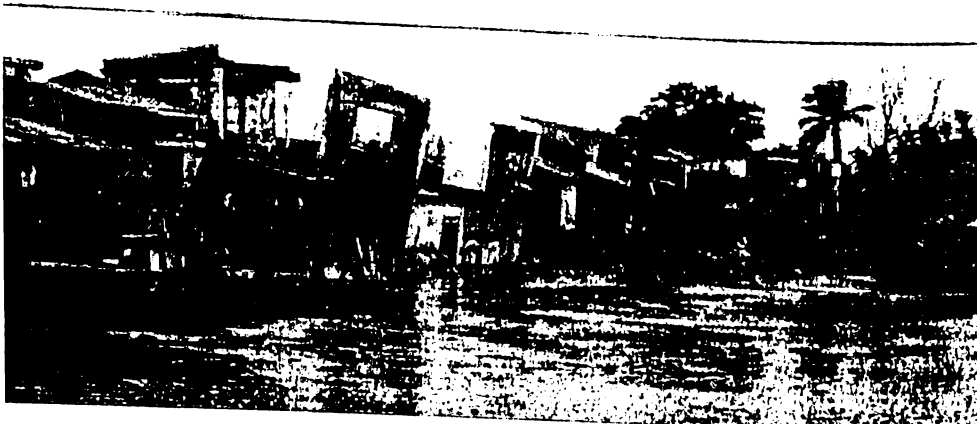
(b)

Lateral spreading in the order of about 3-5 m occurred along the banks of Pantal River. Large lateral displacements and flow failures of the riverbanks, as shown in Figure 6b), account for the damage to several buildings and other structures built near the river. Magsaysay Bridge collapsed as a result of the lateral movement of the opposing banks of Pantal River where the bridge was abutted (Figure 7b). At the same time, the bridge piers sank and tilted towards the centre of the river as a result of the liquefaction of the river bed. Several kilometers of roads became virtually impassable due to cracks in road pavements as a consequence of general subsidence and lateral displacements in the area (Figure 8b).

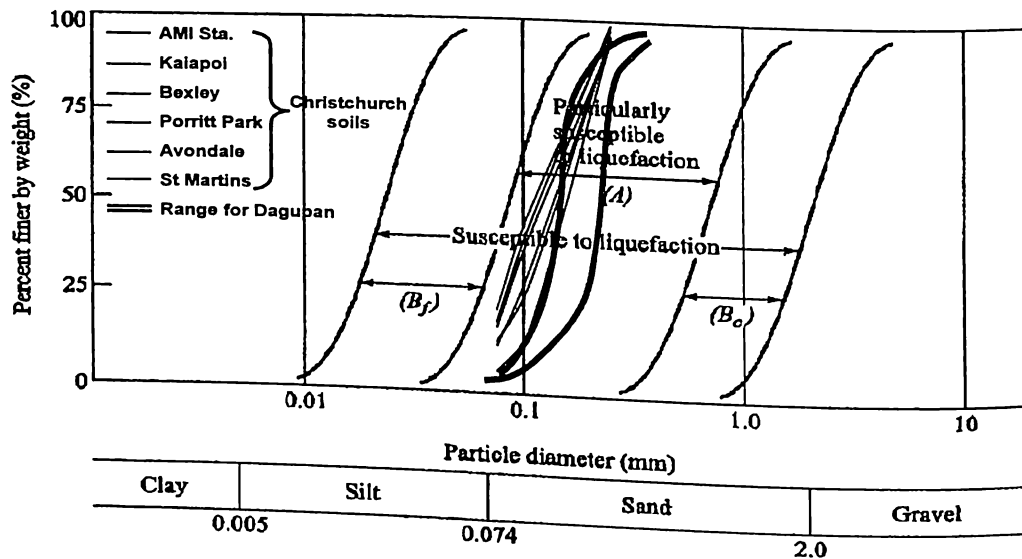
After both earthquakes, the affected areas were covered by ejected water and sand boils. In all places visited in Christchurch after the 2011 earthquake, the appearance of the ejected sands as a result of liquefaction were very similar, typically grey to dark grey in colour and consisting of very fine sands. Samples were taken at various locations and the grain size distributions were obtained by sieving. Figure 9 shows the grain size distribution curves of soil samples taken at AMI Stadium, Kaiapoi, Bexley, Porritt Park, Avonside and St Martins. It can be observed that the distributions of grain sizes were fairly similar, and they plot over a narrow range. The fines contents were low, ranging from 10-25%. Also indicated in the figure is the range of grain sizes obtained in Dagupan City, where the sand boils which erupted from cracks in the ground were generally black to dark grey in colour (Orense et al., 1991). It can be seen that the Dagupan sands are poorly graded with very few fines contents (<10%), when compared to Christchurch soils.

Also shown in the figure are the range of grain size distributions of sands which are deemed to have high possibility of liquefaction (A) and possibility of liquefaction (B). These ranges were obtained from past historical earthquakes in Japan and stipulated in the Japanese design code for port and harbour facilities (PHRI 1997). Note that there are problems associated with the use of compositional criteria as a measure of liquefaction susceptibility because there are no generally accepted criteria and the difference between natural and reclaimed deposits. Nevertheless, using these criteria, it can be seen that the ejected sands obtained at different locations in Christchurch and Dagupan can be said to have high potential to liquefy.

Figure 9. Grain size distribution curves of ejected sands from different sites in Christchurch and Dagupan.

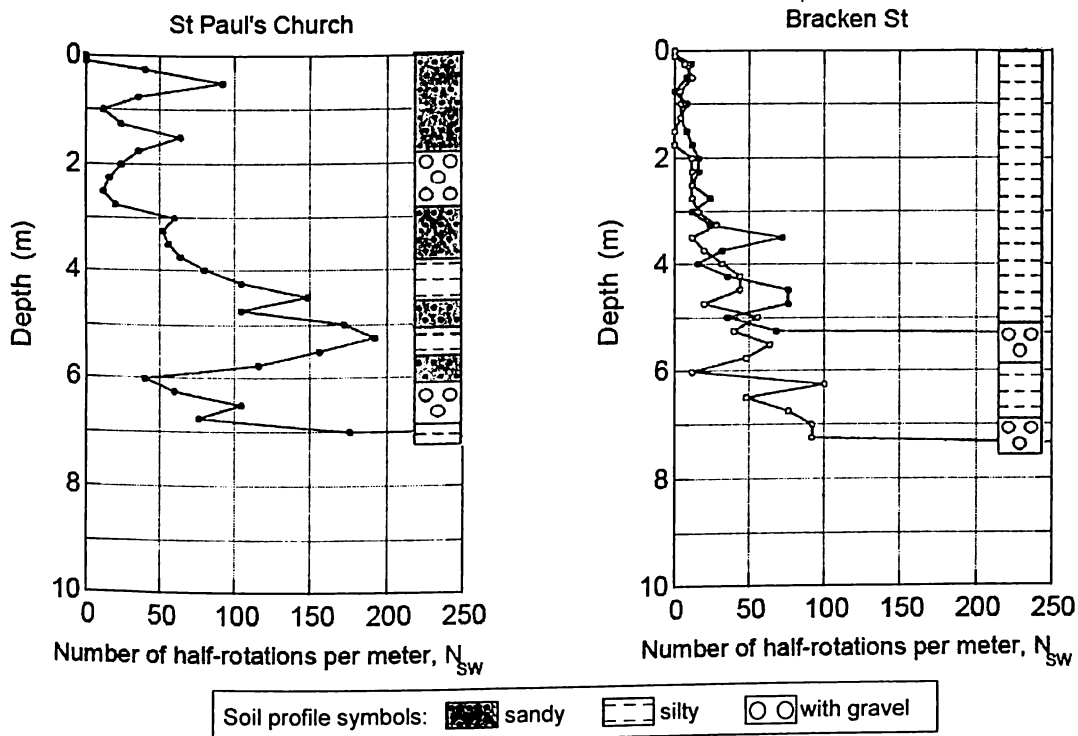
After the earthquake, Swedish weight sounding (SWS) tests were performed at numerous locations in Christchurch and Kaiapoi. In SWS test, a screw-type tip called screw point is penetrated by increasing step-wise the static load, W_{sw} , until it reaches a total of 100 kg. Further penetration is carried out by manually rotating the screw rod while applying the 100 kg static weight and the number of half-revolutions required for one metre of penetration, N_{sw} , is obtained (JSA, 1995). Typical results of SWS tests conducted in Christchurch, expressed in terms of N_{sw} , are shown in Figure 10. It can be seen that zones where penetration is low (loose deposit, $N_{sw} < 100$) consist of sandy to silty soil, with depths ranging from 5-7m.

Figure 10. SWS test results in Dallington and Avonside following the Darfield Earthquake (after Cubrinovski and Orense, 2010).

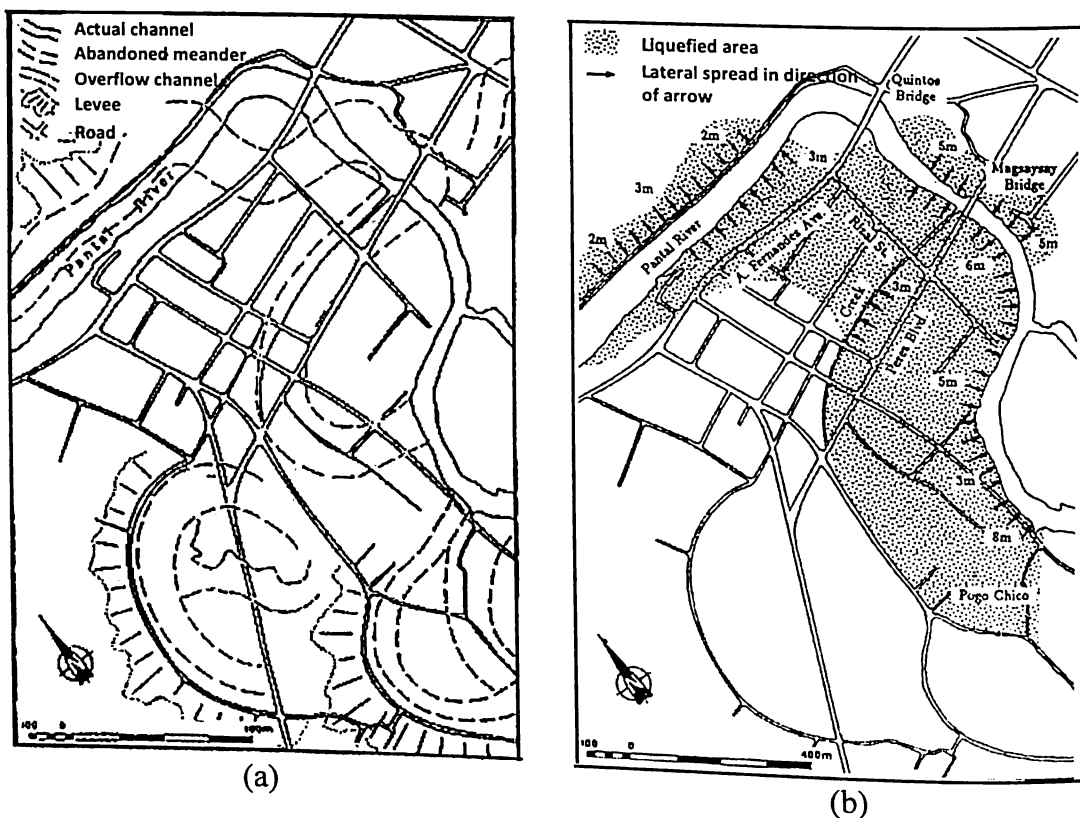
Liquefaction-induced damage observed in Dagupan City correlated very well with the geomorphology of the site. The locations of former river channels within the city are shown in Figure 11(a). The shift of the river courses took place for a long geologic era, and therefore the abandoned portions of the river channel are not man-made fills, but were created probably by transport of sediments during flooding and inundation (Orense, 2003). The area of old channels is composed of loose deposits of silts and sands, and thus susceptible to liquefaction during earthquakes. On the other hand, the locations where signs of liquefaction, such as sand boils and fissures, are shown in Figure 11(b). Note the strong correlation between the locations of reclaimed areas and the damage distribution.

Figure 11. (a) Locations of abandoned meanders in Dagupan (after Punongbayan and Torres, 1990); (b) areas where liquefaction-induced damage was observed (after Orense et al., 1991).

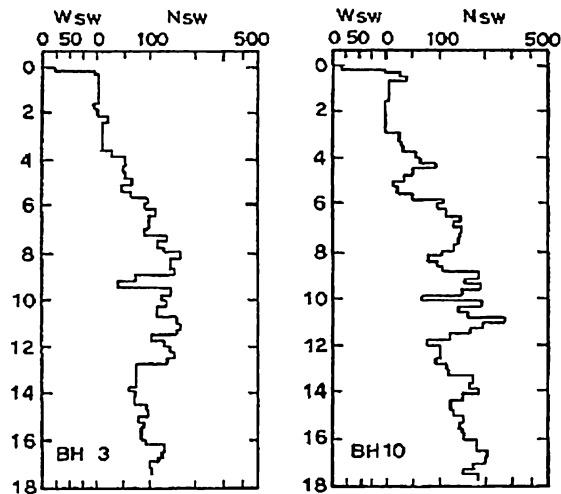
SWS tests were also performed at damaged areas in Dagupan City after the event, and typical results are plotted in Figure 12. It can be seen that there exists a layer to a depth of about 6-7m where the resistance to penetration is low ($N_{sw} < 100$), indicating loose deposits which are susceptible to liquefaction.

Figure 12. Typical results of SWS tests in Dagupan City (after Ishihara et al., 1993)

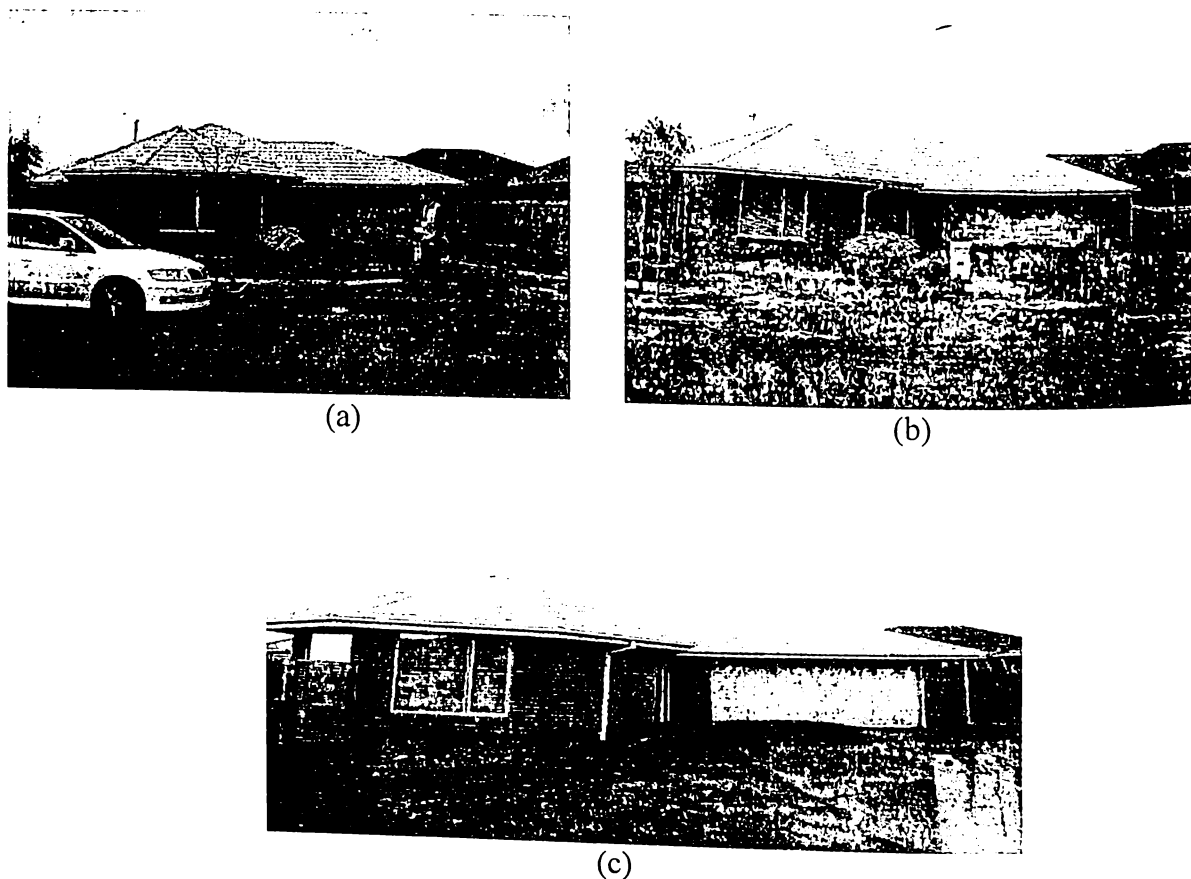
Figure 13. Comparison of damage to a house in Bexley: (a) after 4 September 2010 earthquake; (b) after 22 February 2011 earthquake; and (c) after 13 June 2011 earthquake.

Figure 13(a) shows a house in Seabreeze close in Bexley, which was damaged following the September 2010 earthquake. Note the volume of ejected materials adjacent to the house, with thickness of about 20cm. Following the February 2011 earthquake, more sand boils were observed in the area (about 55cm thick), with the house undergoing more tilt as a result of uneven settlement, as shown in Figure 13(b). When the site was again visited following the 13 June aftershock, ejected sands were again observed in the vicinity of the house, with thickness of about 15cm (see Figure 13c).
