Some Steps Towards the Development of Low-Cost Typhoon Resistant Housing in the Philippines

Geoffrey N. Boughton*

With Assistance From The Typhoon Assessment Group for Typhoon Damaged Houses Building Research Service

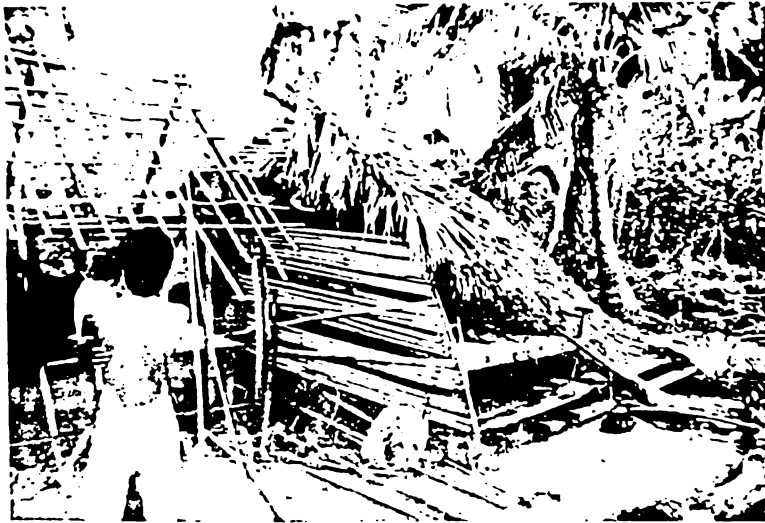
No bracing was observed in the walls of any of the houses that used these systems. As a result, racking had occurred with all of the systems. With the split bamboo lengths, the racking was so severe that the house was frequently a total loss as is shown in Figure 5. Houses with sawali and crushed bamboo seemed to be stiffer, and the resulting racking deflection was often small, leaving the house quite serviceable.

Figure 5. Racking Failure of an Unbraced House

The installation of a small number of simple diagonal braces in the walls of these houses would have in many cases prevented any racking damage from occurring and in all cases would have significantly reduced the movement so that the houses could still be safely occupied.

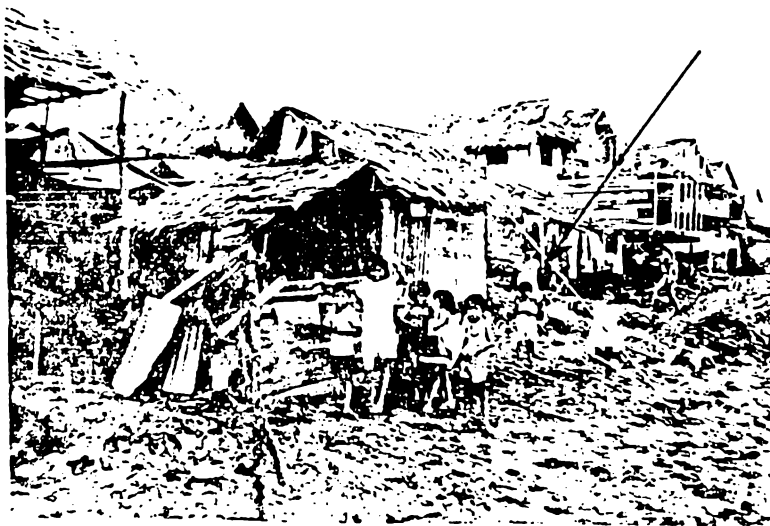
External diagonal braces were used on a number of houses. These braces ran from eaves level to the ground as shown in Figure 6. The purpose of this brace was to secure the house against lateral movement; however, the braces had proved largely ineffective.

The braces were rarely tied at the bottom which meant that they could carry no tension, and their slenderness prevented them from carrying much compression. Their value appears to be psychological.

**Figure 6. External Bamboo Bracing
(Arrowed)**
