Slope Failures Triggered by Heavy Rainfall

Rolando P. Orense*

*Department of Civil Engineering
Yamaguchi University Tokiwadai
Ube-shi 755-8611 JAPAN*

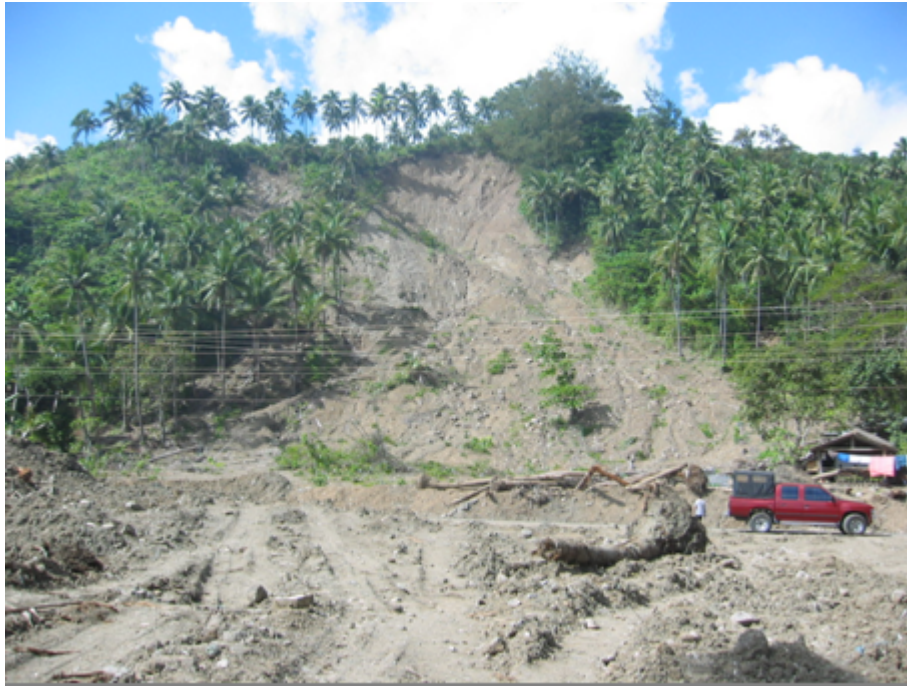
Figure 2. View of landslide in Real town where more than 100 people were killed

landslides involved only surficial soils and were not deep-seated. Rockslides and rockfalls were also observed near mountain streams. In one of the worst hit areas in Real town, about 100 persons were trapped when a three-storey building being used as an evacuation site collapsed under the impact of one landslide. The site is shown in Figure 2. Moreover, five road bridges were destroyed by the sediment- and debris-laden flood waters, and logs and debris blocked major portions of the national highway, rendering Real and adjacent towns inaccessible to traffic for several weeks. One of the washed-out bridges is shown in Figure 3. In the aftermath of the disaster, government officials blamed the logging activities in the southeastern portion of Sierra Madre mountain ranges as the main cause of landslides and floods in the affected areas. However, aerial photos showed that in the southwestern portion of the mountain ranges, which have almost similar geologic and topographic features, very few landslides occurred although forest cover was very little. Further inspection reveals that landslides were prevalent in steep slopes, whether forested or not. The results of preliminary investigations (Orense et al., [6]) suggest that the heavy rainfall preceding the disaster is the main cause of the slides. Samples obtained in Real and Infanta indicate that the soils in the affected are silty sand and sandy

silt, with very few clay content ($< 11\%$). The heavy rainfall saturated the slopes, leading to loss in shear strength and resulted in failures. The existence of highly fractured rocks, steep slopes and thick soil cover also contributed to the mobilization of slope failures. Environmental conditions, particularly land use and logging, were not the main cause of the landslides, but may have contributed to the impact and scale of the disaster.

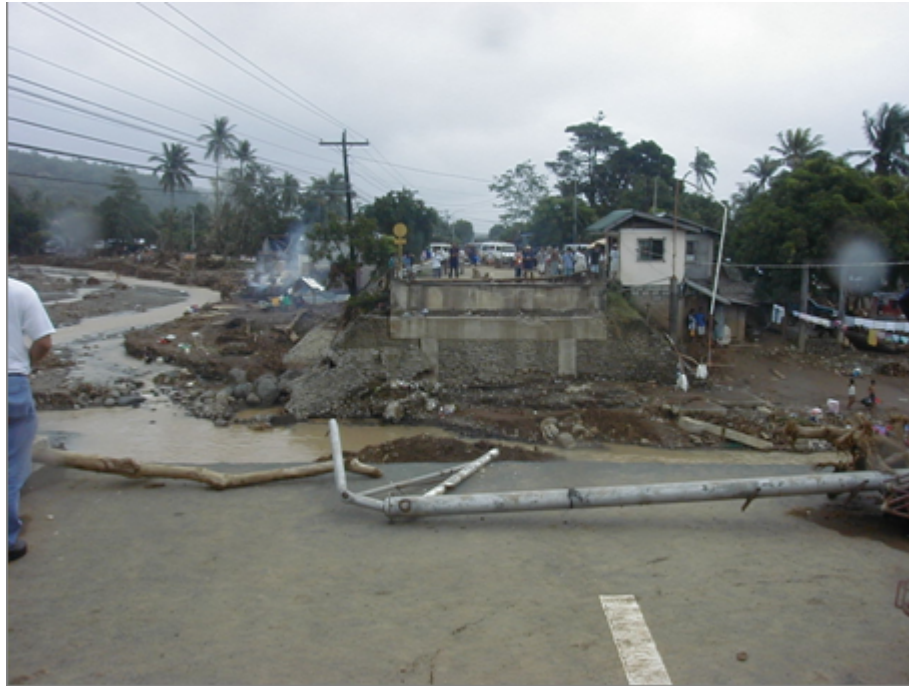
Figure 3. Real Bridge washed out by the flash floods and debris flows (Photo by E. Billedo)

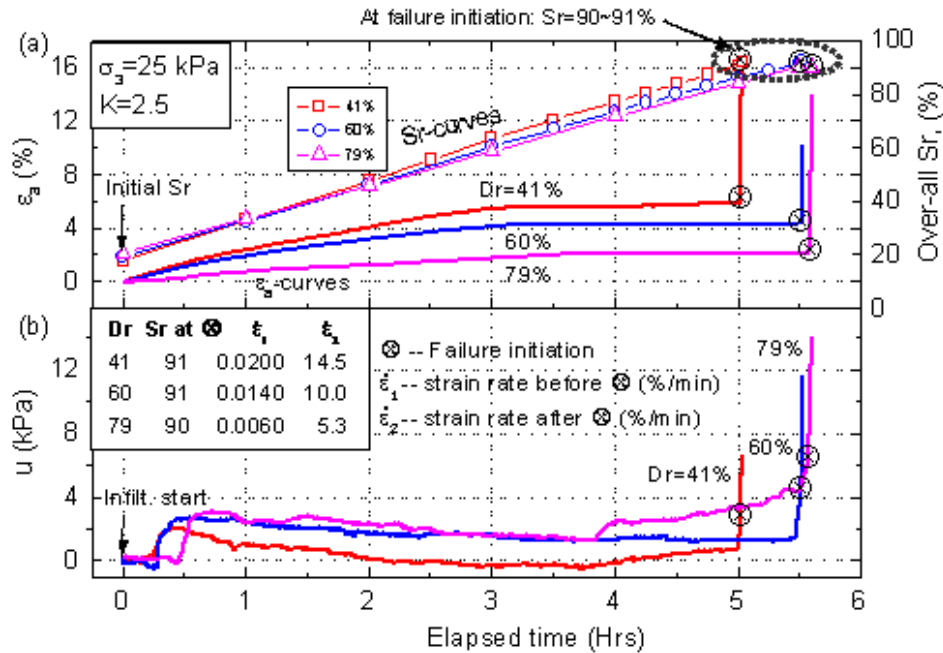
Figure 6. Time histories of: (a) axial strain, ϵ_a , and over-all degree of saturation, S_r ; (b) pore water pressure, u , showing the effect of varying relative density, D_r .

its yield point and axial strain increased suddenly. This point is defined as the failure initiation of the soil specimen. Once failure initiation point was reached (denoted by \otimes in the figure), the development of ϵ_a progressed rapidly and large strains ($>10\%$) were reached in relatively short time. Values of S_r when failure was induced were in the range of $90 \sim 91\%$ for all specimens. Strain rates before ($\dot{\epsilon}_1$) and after ($\dot{\epsilon}_2$) failure initiation were measured in all specimens, and it was observed that both strain rates increased as D_r decreased. This observation implies that loose soil slopes would undergo more rapid deformation than dense ones when subjected to rainfall infiltration.

Figure 6(b) shows the variation of monitored pore-water pressure inside the sample. Note that although there was negative pore-water pressure (soil suction) present within the specimen during the initial phase of water infiltration, it was not read by the miniature transducer as it could measure only positive values. In all tests, there was an increase in pressure of about $2 \sim 3$ kPa, followed by gradual decrease. Such increase may have been caused by pore-air pressure as the infiltrating water pushed up the entrapped air from the bottom portion of the specimen. Since the top end of the specimen was vented to the atmosphere, the pressure dissipated gradually.

When sufficient level of S_r was attained within the specimen, pore-water pressure started to increase and, consequently, failure was initiated within the specimen. It can be surmised from Figure 6 that the sudden increase in pore-water pressure is preceded by the reduction in initial suction within the specimen following the saturation process.

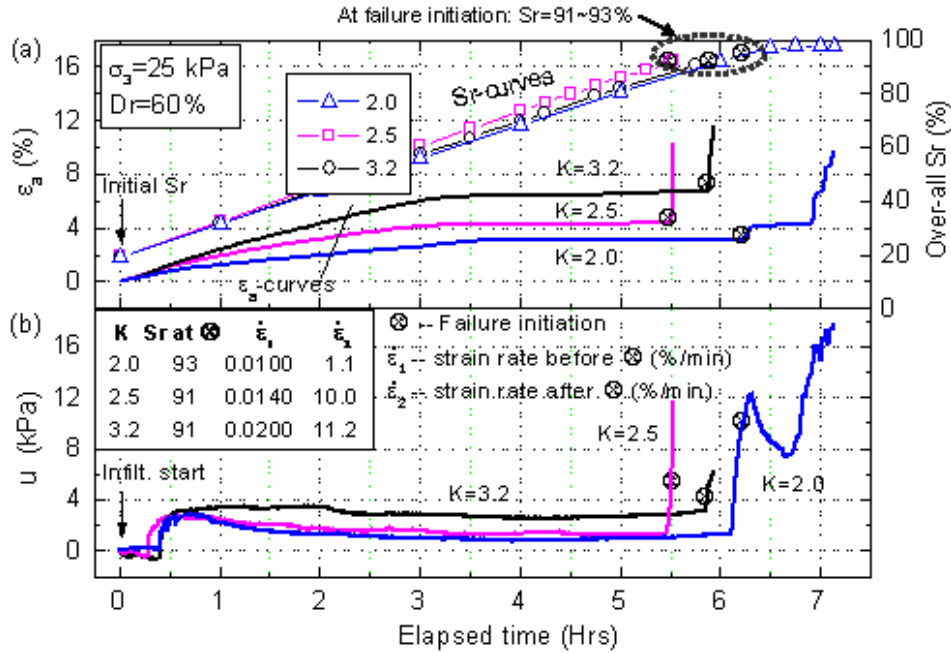
Figure 7. Time histories of: (a) axial strain, ϵ_a , and over-all degree of saturation, S_r ; (b) pore water pressure, u , showing the effect of principal stress ratio, K

Results considering the effects of initial principal stress ratio K , indicative of degree of slope inclination, are shown in Figure 7. In these tests, initial $D_r=60\%$ and $\sigma_3=25$ kPa were kept constant and values of initial K were varied from 2.0 ~ 3.2. As in previous case, test results showed practically bi-linear deformation time history, i.e., very small axial strains during the initial phase of water infiltration followed by rapid increase once failure initiation point was reached. Moreover, failure was induced in soil specimens at essentially constant $S_r(= 91 \sim 93\%)$, irrespective of initial K . Detailed examination of Figure 7 shows that strain rates before ($\dot{\epsilon}_1$) and after ($\dot{\epsilon}_2$) failure initiation are greater for higher values of K , indicating that more rapid ground movement would be expected for steeper slopes than for mild ones. This observation is consistent with the general idea that slope gradient is a significant factor in establishing the instability state as well as the post-failure initiation condition of slopes.

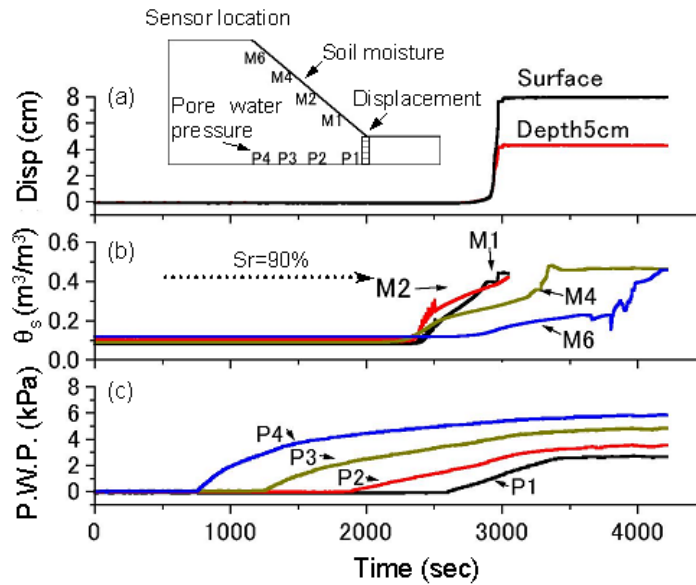
Figure 8. Time histories of: (a) toe displacement; (b) volumetric water content; (c) pore-water pressure at sensor locations (Case 1: seepage test)

Figure 8 shows the monitored time histories of the lateral displacement (as monitored by the shear displacement transducer near the toe of slope and directed parallel to the the slope), volumetric water contents (defined as the ratio of the volume of water in the soil pores to the total volume) (θ_s) and pore-water pressures (PWP) at the sensor locations. The progress of wetting front (i.e., the boundary between the wetted soil and dry soil that forms during water infiltration) within the slope is indicated by the temporal development of pore-water pressure. The pore pressure readings show gradual increase in pore-water pressure, starting from the left side of the slope, consistent with the movement of the wetting front. When the region where M1 and M2 sensors were located was saturated (corresponding to $S_r=90\%$), the ground started to deform in a very rapid manner. The maximum surface displacement near the toe was about 8 cm, while deformation 5 cm below the surface was 4 cm. This indicates that only superficial portion of the slope was involved in the movement.

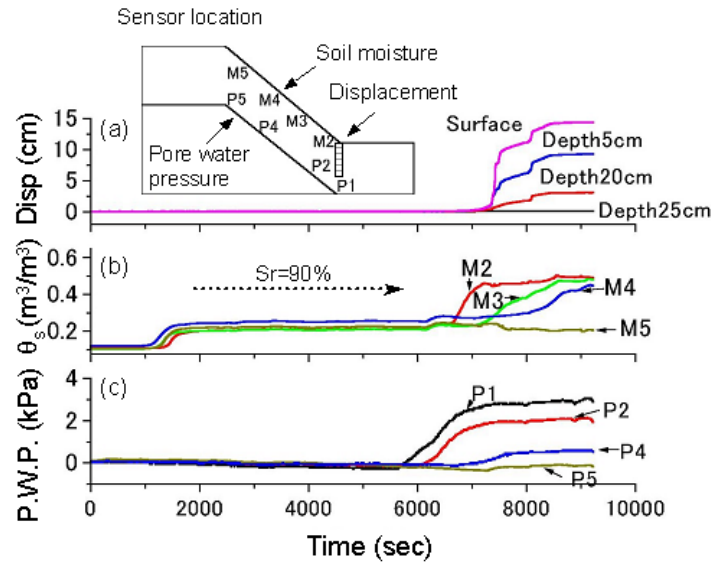
Figure 9. Time histories of: (a) toe displacement; (b) volumetric water content; and (c) pore-water pressure at sensor locations (Case 2: rainfall test)

Figure 9 shows the time histories of toe displacement, volumetric moisture contents and pore-water pressures. At about $t=1000$ sec, the infiltrating rainwater reached the soil moisture

transducers located 5 cm from the ground surface, and the soil moisture contents increased simultaneously. However, they remained constant as the wetting front progressed downward toward the impermeable base. As infiltration continued, a water table developed at the base of the slope, and pore-water pressure increased at P1 and P2 (at about $t=5600$ sec). When the water table approached M2 location, the soil moisture content at this point increased and when it registered $\theta_s=0.42$ (equivalent to $S_r=90\%$), the slope began to move. Displacement of about 14 cm was recorded near the toe of the slope.

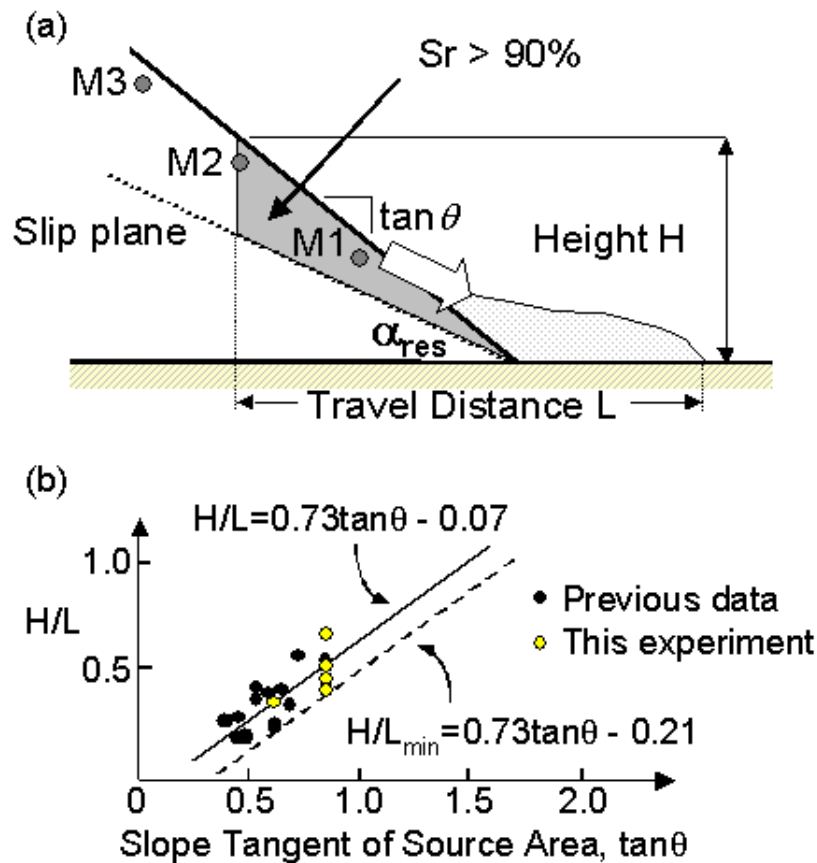
Figure 10. Basis of monitoring scheme: (a) zone with high potential to sliding, (b) relation between H/L and slope tangent of slide source area

The results of model tests indicate the inclinations of the remaining portion of the slopes after failure (defined as residual slope angle α_{res}) are the same for all cases. For Omigawa soil, it was observed from model tests that $\alpha_{res} = 20^\circ$ (Orense et al., [16]). Thus, as shown in Figure 10(a), failure is assumed to involve the triangular region above α_{res} where soil moisture content exceeds the threshold value corresponding to the soil type present in the slope (e.g., $S_r = 90 \sim 91\%$ for Omigawa soil).

Next, the travel distance of the failed portion of the slope is estimated. For this purpose, results of field survey done by Moriwaki [17] on actual slope failures due to rainfall are used. The results, shown as black dots in Figure 10(b), showed a linear relation between the slope tangent at the source area and the ratio of slope height to travel distance. The results of all model tests are also plotted in the figure and a good agreement is observed. In using these results, the lower limit shown by the dashed line is employed to be on the safe side. Now, the slope tangent at the source area is generally known from the profile. When the travel distance, L , necessary to impact an important facility is known, the volume of slope involved in failure, which is a function of H , can be estimated. Thus, in the proposed scheme, real-time prediction not only of whether the slope will fail or not, but also the extent of the failed mass and whether it could impact a facility located downslope can be performed.

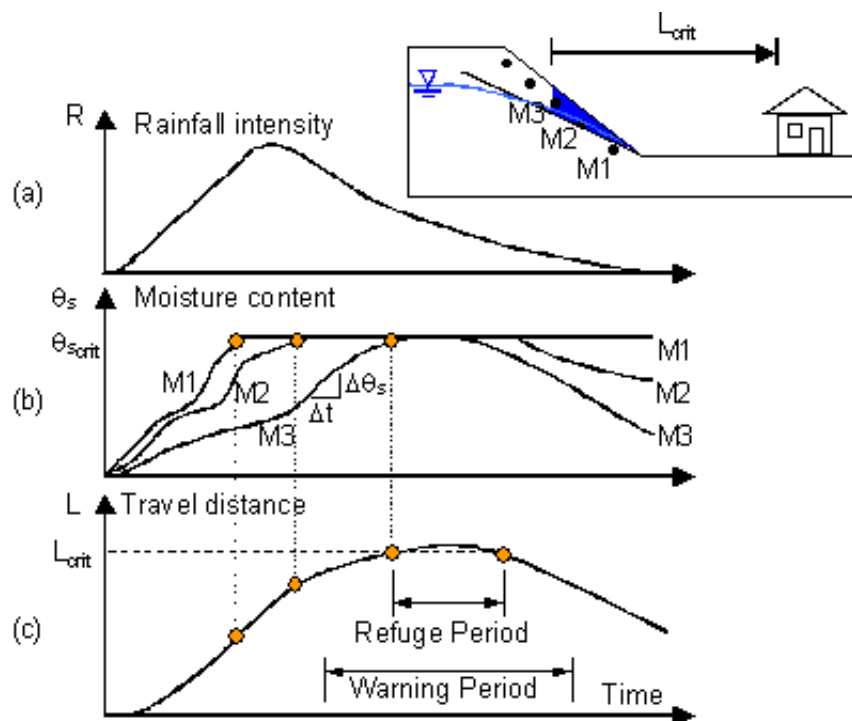
Figure 11. Schematic diagram showing the time histories of: (a) rainfall, R ; (b) moisture content, θ_s ; (c) travel distance, L

The proposed scheme is shown schematically in Figure 11. For a given rainfall data shown in Figure 11(a), moisture contents within the slope will rise, possibly starting with that near the toe (Figure 11b). From the moisture readings, the expansion of saturated region above the slip surface can be assessed in real-time and estimates of failed soil volume and the corresponding travel distance can be made (Figure 11c). When the estimated travel distance L reaches a critical value (L_{crit}) such that it would impact the facility downslope, a warning is issued. The warning is cancelled when the estimated L drops below L_{crit} .
