Nondestructive Evaluation of Masonry Materials used in Historic Philippine Structures: Case Study of Structural Performance of Manila Cathedral

Mathew Harvey T. Peralta, Melmar B. Piedad and Oscar Victor M. Antonio, Jr.

*Institute of Civil Engineering
University of the Philippines - Diliman
Quezon City, Philippines
mhtperalta@gmail.com*

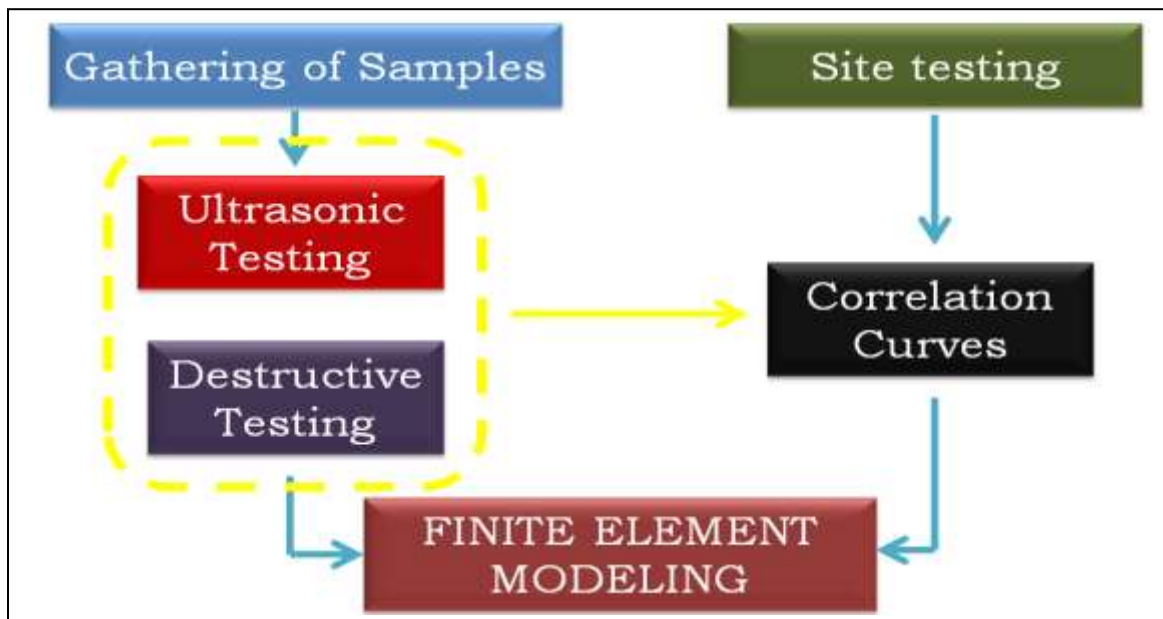
Figure 1. General Methodological Framework

Samples of the material comprising the Manila Cathedral were obtained and brought to the laboratory where ultrasonic testing was conducted to determine the wave characteristics through the material. Ultrasonic pulse velocities were directly obtained from the testing while other ultrasonic parameters such as wave attenuations and frequency distributions were determined through further wave processing. Uniaxial compressive testing was then performed to determine the mechanical properties of the material (i.e. Young's modulus of elasticity and uniaxial compressive strength). These parameters were then correlated with the wave characteristics. Different statistical parameters were used to determine best-fit models for the different sets of parameters.

To determine the actual characteristics of the structure itself, ultrasonic testing was then done on site. The results were used as input parameters to the correlations obtained to determine the mechanical properties. A model of the Cathedral, based largely on the floor model provided by Intramuros Administration, was then constructed in SAP2000 using the obtained material properties and was subjected to different loading conditions to determine the critical sections of the structure.

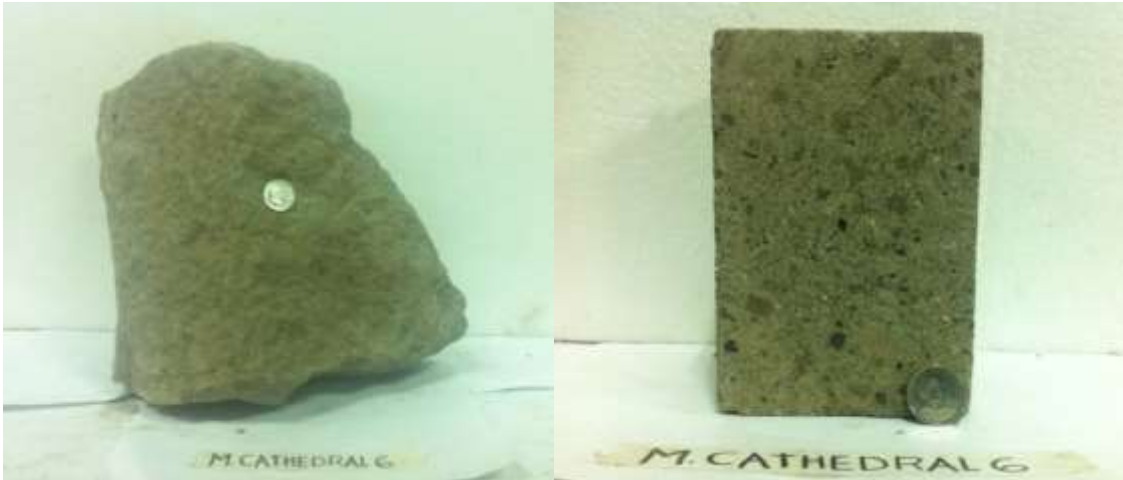
Figure 2. Images before and after cutting of the MC 6 specimen

Samples from the Manila Cathedral were gathered and transported to the Construction Materials and Structures Laboratory (CoMSLab) at UP Diliman. After letting them rest at room temperature for 2-3 days, the specimens were then cut to size using the diamond blade cutter at the CoMSLab. The samples were cut to a square cross-section with 100 millimeter sides and a height of 150 millimeters to be able to keep a 1:1.5 width to height ratio while keeping the minimum path length for the ultrasonic testing. As an example, the images before and after cutting of the 6th specimen from Manila Cathedral are shown in Figure 2.

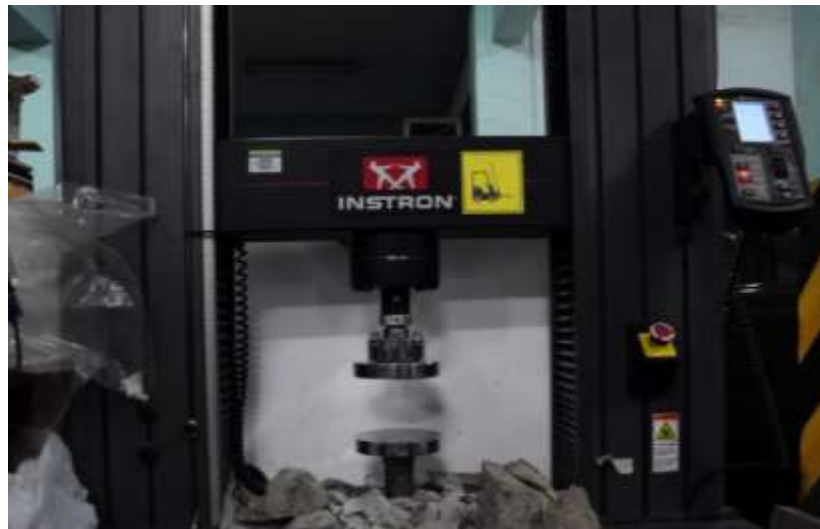
Figure 4. Instron 5982 floor model 100 kN capacity Universal Testing Machine with the control panel shown on the upper right.

After going through ultrasonic testing, the specimens underwent destructive testing. The setup used is shown in Figure 4. The Instron® 5982 floor model 100 kN capacity Universal Testing Machine was used. The equipment comes with a computer interface through the program Bluehill® 3 that allows the user to input the specimen geometry so that it instantaneously obtains the stress based on the load applied. The interface also displays the stress-strain curve as the compressive test goes on. For the test itself, ASTM C1314-12, or the Standard Test Method for Compressive Strength of Masonry Prisms, allows any convenient rate of loading to be used as long as the failure happens between 1-2 minutes. Since the equipment allows for numerous parameters to be taken, the compressive stress at yield and the Young's Modulus of Elasticity were selected as those that will be computed and reported in the output file of each test because these are the parameters to be studied in this research.

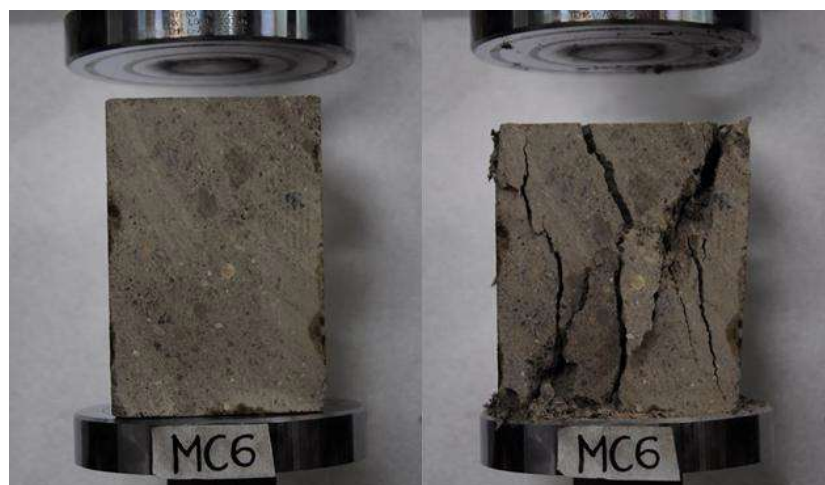
Figure 5. Specimen MC 6 before and after going through destructive testing

An image (like the one shown in Figure 5) was taken directly after testing before a piece of the core was weighed and oven dried for 24 hours to be able to obtain the moisture content at testing.

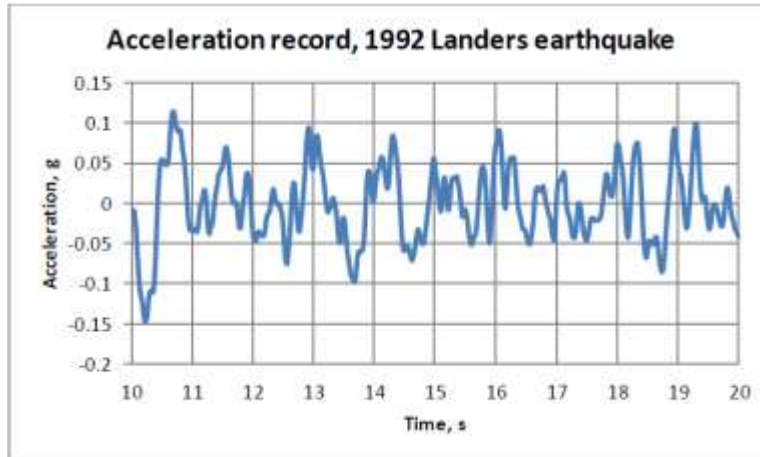
Figure 8. Acceleration record of 1992 Landers earthquake, cut off on the interval $t = [10, 20]$ seconds

This institution maintains an online accessible database of different earthquake records within the period of 1935 to 2010. After considering the geotechnical data of the location of the Cathedral, its distance from the nearest fault (Marikina fault), and the characteristics of the earthquakes it produces, the 1992 Landers earthquake was chosen to which the model will be subjected to. Figure 8 shows the acceleration record of the said earthquake.

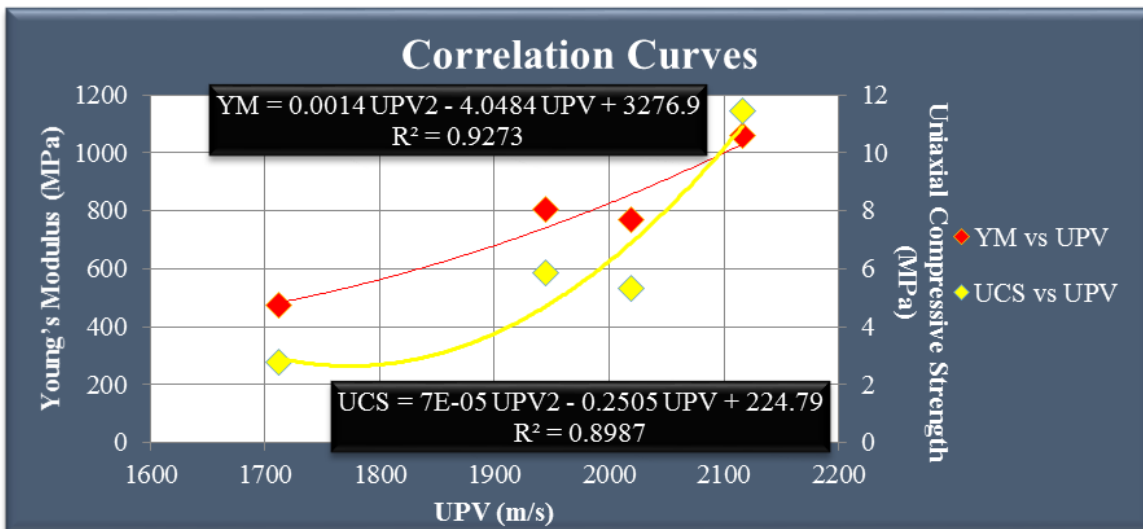
Figure 9. Uniaxial Compressive Strength and Young's Modulus vs. UPV for the Manila Cathedral specimens

Originally, a total of six specimens were obtained from the Manila Cathedral, hence the numbering seen and used in documentation. Unfortunately, specimens 2 & 3 were removed because after undergoing destructive testing, the computer accidentally lost power and the data for them were lost. Nevertheless, the four remaining were still used to come up with correlations between the destructive and non-destructive parameters. Figure 9 shows the relationship of the UPV with the UCS and YM of the Manila Cathedral Specimens.

Through regression analysis, it was found out that the best fit between UPV and the destructive testing parameters are 2nd degree polynomial relationships. Both cases show very high coefficients of determination (R^2) with values around 0.90. An R^2 value close to unity means that the fit is very good, but caution must be taken because this might be partially due to the limited number of specimens taken. It should also be noted that these equations are obviously empirical and use parameters with respective units (MPa and m/s). These curves, together with the results from the in-situ tests, will be used as basis for the strength based model. As for the non-linear time history analysis, stress-strain diagrams are needed. The results from the laboratory tests of the samples are shown in Figure 10. As observed, sample MC4 provided the highest elastic stress-strain data among the samples, while MC1 has the lowest registered compressive strength. It also shows that the samples tend to consolidate after initial cracking in order to sustain more load.

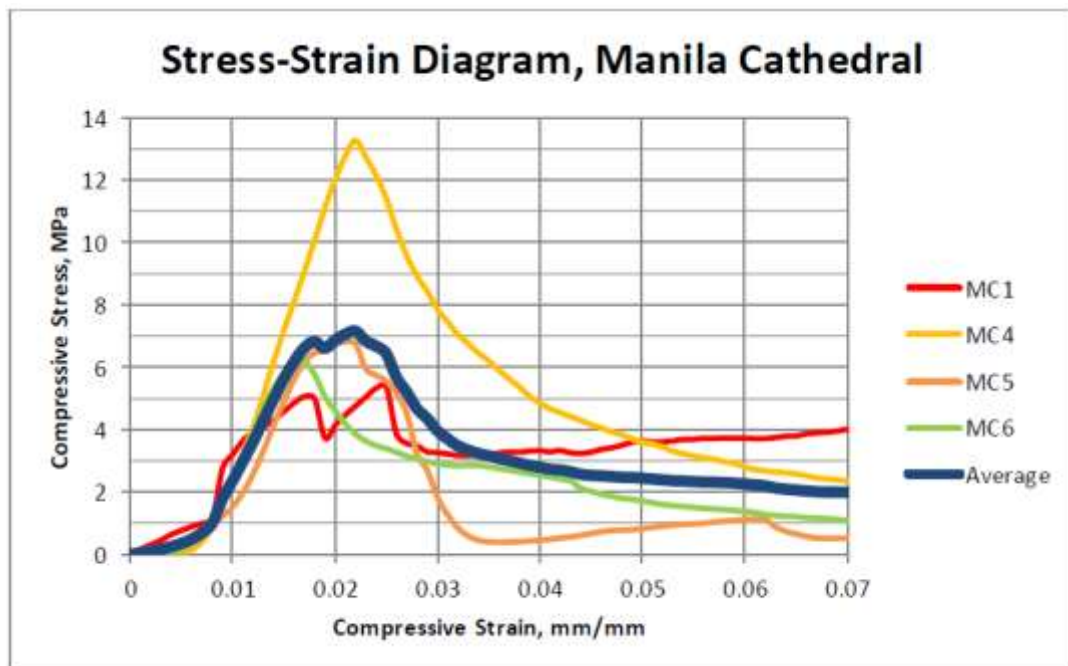
Figure 10. Stress-strain diagram of the Manila Cathedral samples and their average values

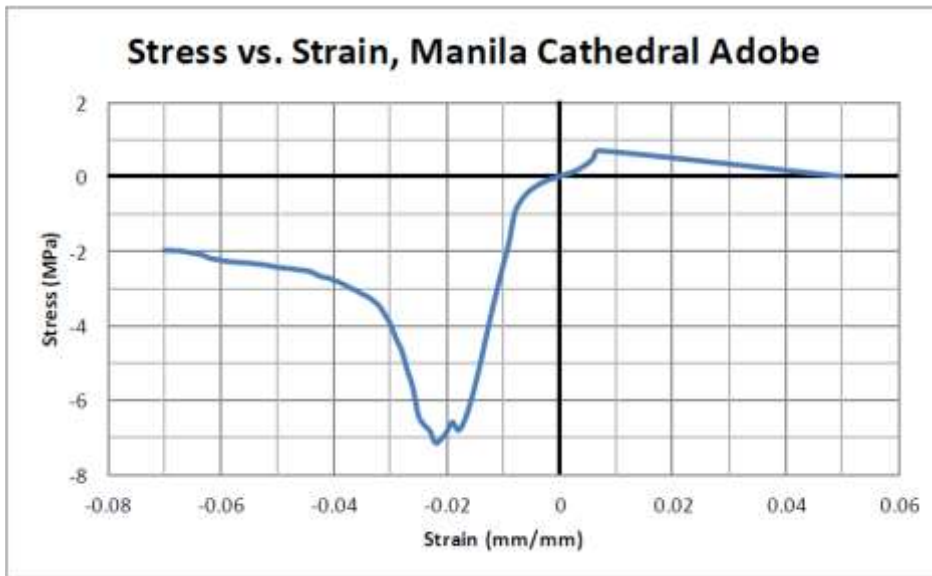
Figure 11. Modified stress-strain diagram of the Manila Cathedral samples

To be able to perform the time history analysis, the behavior of the material in tension must also be obtained. Figure 11 shows the modified stress-strain diagram for Manila Cathedral adobe, as stated in [8]. This modification included the tensile behavior of the adobe material. As shown in the figure, the tensile stress of Manila Cathedral adobe is approximately equal to 0.64 MPa (~10 % of its compressive strength), while it reaches tensile failure at approximately 0.05 mm/mm. The blue line was determined from the average values of the different MC samples. This average stress strain diagram was used in modeling the material comprising the structure.

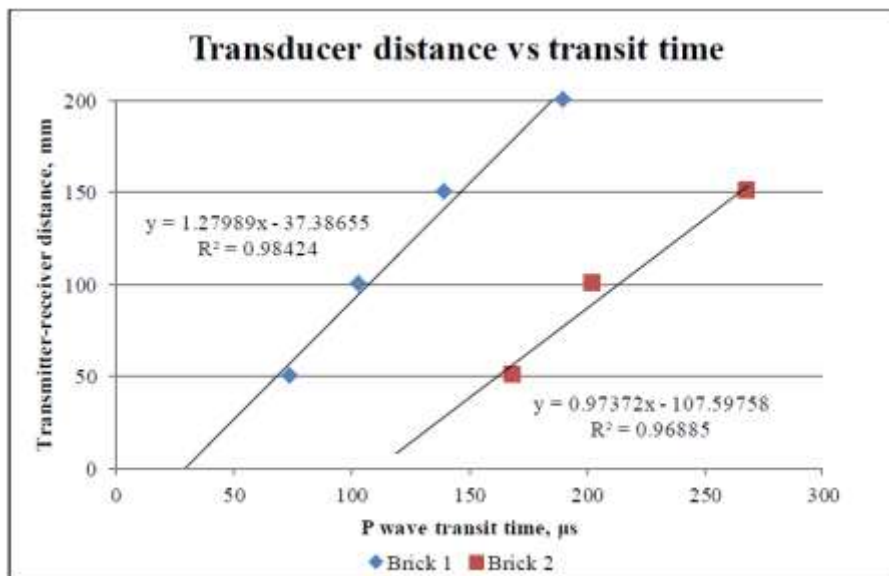
Figure 12. Determination of P-wave transit time (as UPV) in varying transducer distances

After doing non-destructive *in-situ* testing on the wall of Manila Cathedral, the P-wave velocity transit times, which are already determined by PUNDITLink, were then plotted against the corresponding transducer distances. The slope of the best-fit line corresponds to the ultrasonic pulse velocity (UPV) of that section, assuming that the wall has uniform thickness. Figure 12 shows the measurements taken from bricks 1 and 2 and simultaneously plotted.
