Building in 19th Century Philippines

Abstract

Structure B

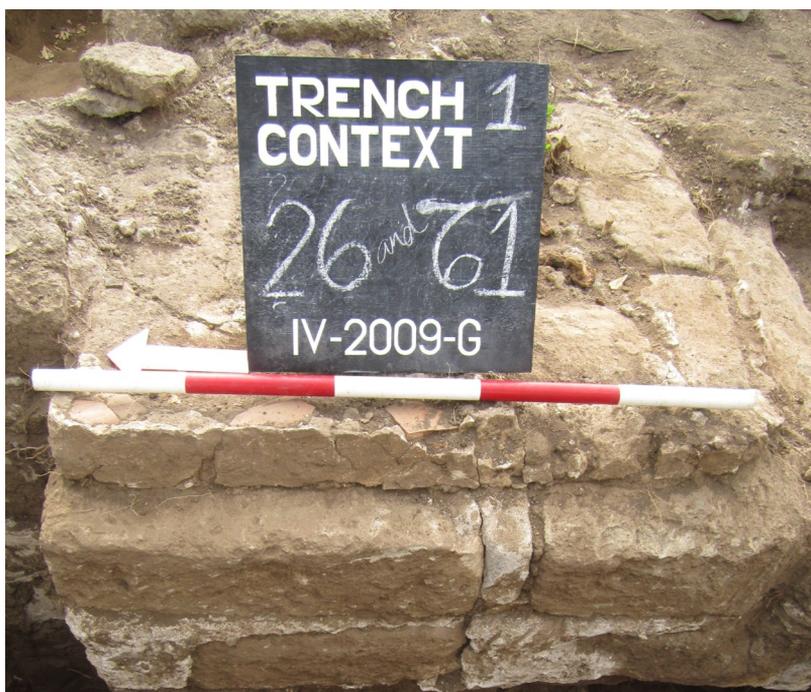
Figure 2: A pillar base made of tuff stone blocks bound by lime mortar and exhibiting evidence of lime mortar finishing for what used to be a pillar in the southwest corner of Structure B.

These stone blocks varied in size. The stone blocks used in the eastern portion of the structure were slightly larger than those on the western side. The sizes of the stone blocks in the western portion, based on what was exposed, ranged from 23 cm to 26 cm x 54 cm to 62 cm x 16 cm while those used in the eastern half ranged from 17 cm to 20 cm x 60 cm to 64 cm x 27 cm. These stone blocks were bound by and plastered with lime mortar and cement for some parts of the structure (Figure 2). Lime mortar and cement were also used as fill for the structure’s pillars (Figure 3). Mortar requires aggregates to increase its strength (Figure 4). In the case of Structure B, several types of aggregates were used. *Tisa* or clay roof tile fragments were the most common aggregate in the structure (Figure 5a). *Baldoza* or clay floor tiles were also used, as well as shells, ceramic sherds, and scoria (Figures 5b and 5c).

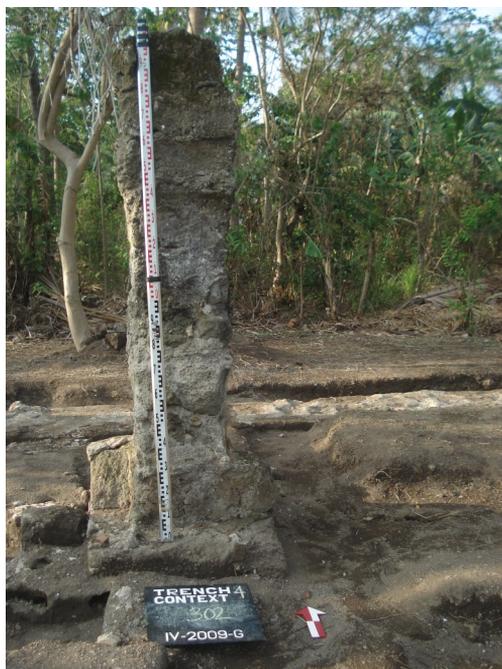
Figure 3: Lime mortar fill of a pillar within the eastern half of Structure B. (Photo by K. Tantuico).

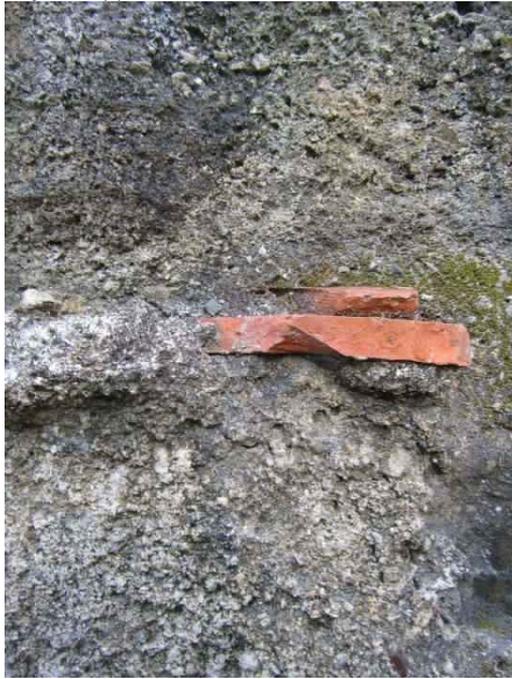
Figure 4: Roof tile fragments used as aggregates for a pillar grout. (Photo by K. Tantuico).

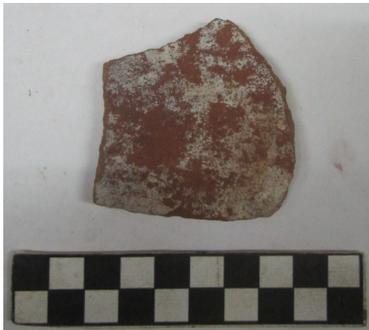
Figure 5a: *Tisa* fragments with evidence of being used as aggregates.

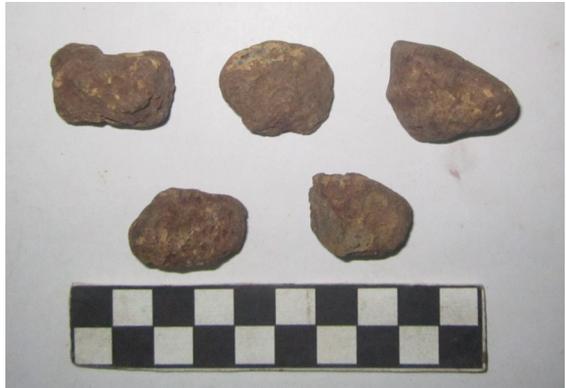
Figure 5b: Scoria collected from Structure B.

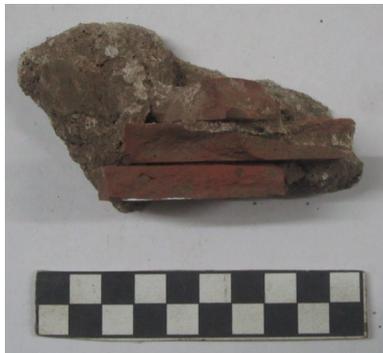
Figure 5c: Earthenware sherd with evidence of being used as an aggregate.

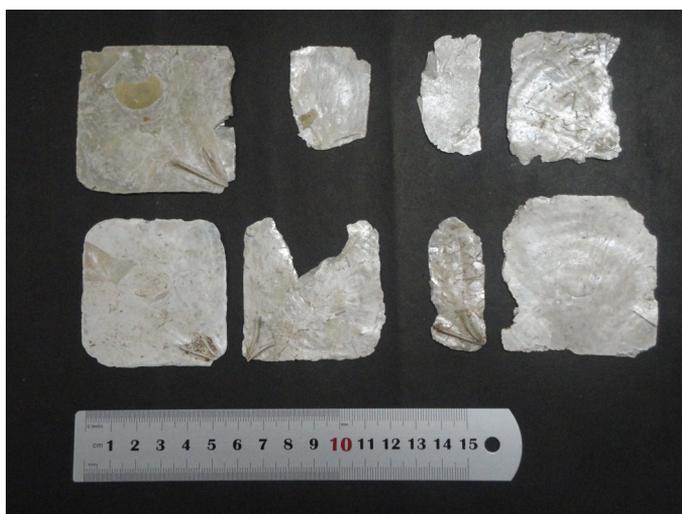
Figure 6: Capiz shells used in windows (Photo by M. Reyes).

Tuff and conglomerate stone blocks, lime mortar, and cement along with various aggregates comprised the structure's foundations, walls, and pillars. Along with these masonry materials, though, locals accounted for wooden posts which they identified as *mulawin* or commonly known as molave (*Vitex parviflora*). These wooden posts were supposedly taken during the destruction of the structure, explaining why the only archaeological evidence found were post holes, post bases, and their foundations. There were six post holes unearthed and one more that could have possibly been a post hole but was no longer explored. These, however, accounted only for the structure's ground floor. According to interviews with local residents, the structure had a second floor made of thick wooden slabs or *tabla*. These, too, were supposedly made of hardwood. Furthermore, according to one account, the second floor was wrapped in *capiz* windows. Consistent with archaeological evidence, worked *capiz* shells were retrieved from the site (Figure 6).

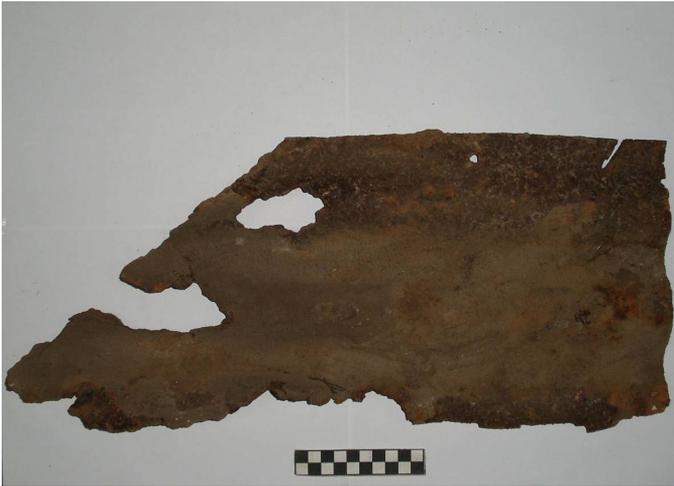
Figure 7: Corrugated galvanised iron sheet fragment (Photo by H. Valerio).

The structure's roofing was corrugated galvanised iron (G.I.) sheets. This is supported by a sizeable G.I. sheet fragment recovered from Trench 4 (UP-ASP 2011) (Figure 7) further supported by archival records. According to Mayo (2010), the old town of San Juan, identified as the current Barangay Pinagbayanan, had six families who owned stone houses with metal roofs. With regard to the structure's entryway, local accounts vary. Some said the structure had one entryway on the west facing the current main road. A few said there were two entryways. Archaeological evidence supports that at one point there could have been two entryways.

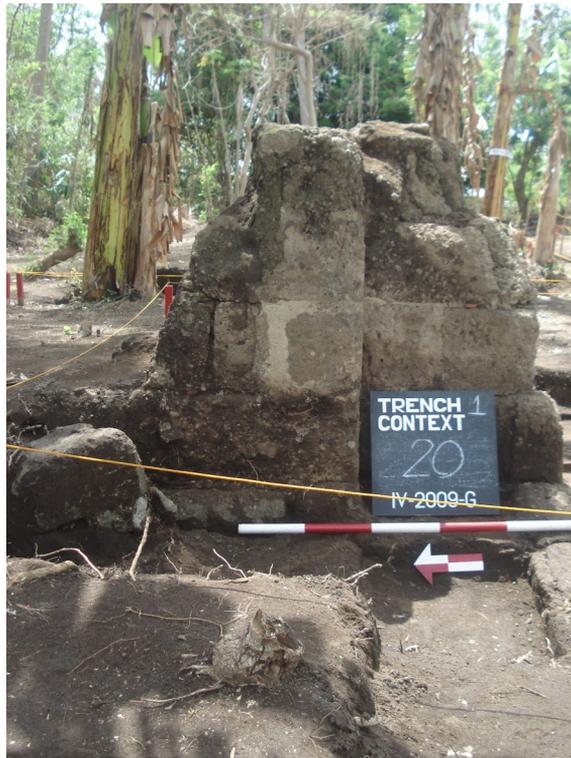
Figure 8a: West view of the northwest corner.

The south face of the northwest corner had a smooth finishing suggesting that it was the end of the feature and not a result of the structure's destruction. There was also a mortar bed with stone block impressions connecting the northwest corner to the west wall, and leading up to this area from the west are stone block pavers (Figures 8a and 8b). According to local accounts, the entryway was big enough to fit a horse carriage. The distance between the south face of the northwest corner to the edge of the west wall was approximately 165 cm, a reasonable width which may have been wide enough for a horse carriage. Another entryway was directly across the west entryway to the east also with pavers leading up to it. This was smaller though, with a width of 140 cm, and had evidence of being closed off. The door to the main entryway was said to have been made of hardwood. Again, no evidence of this wooden door was found except for metal hinges that are decidedly thicker and bigger than those currently used in houses (Figures 9a and 9b).

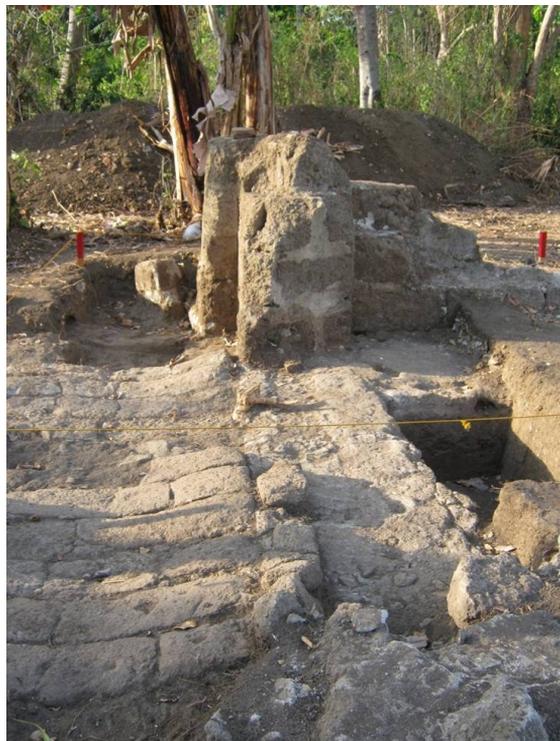
Figure 8b: South view of the northwest corner with attached pavers.

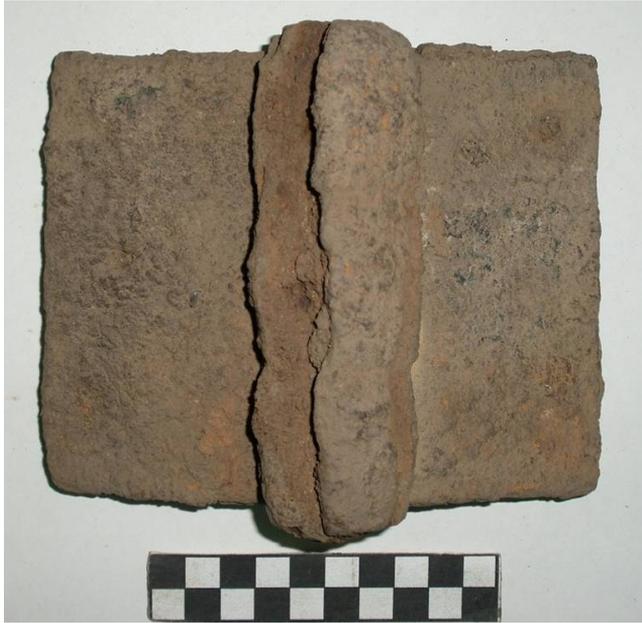
Figure 9a: A corroded metal butterfly hinge (Photo by H. Valerio).

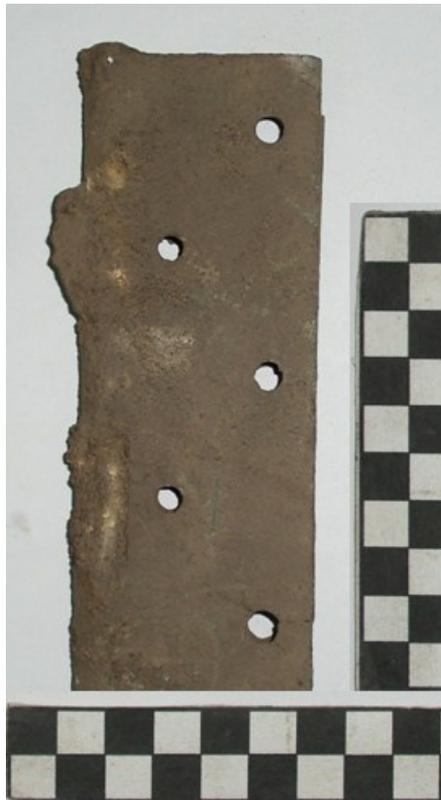
Figure 9b: Half of a metal hinge.

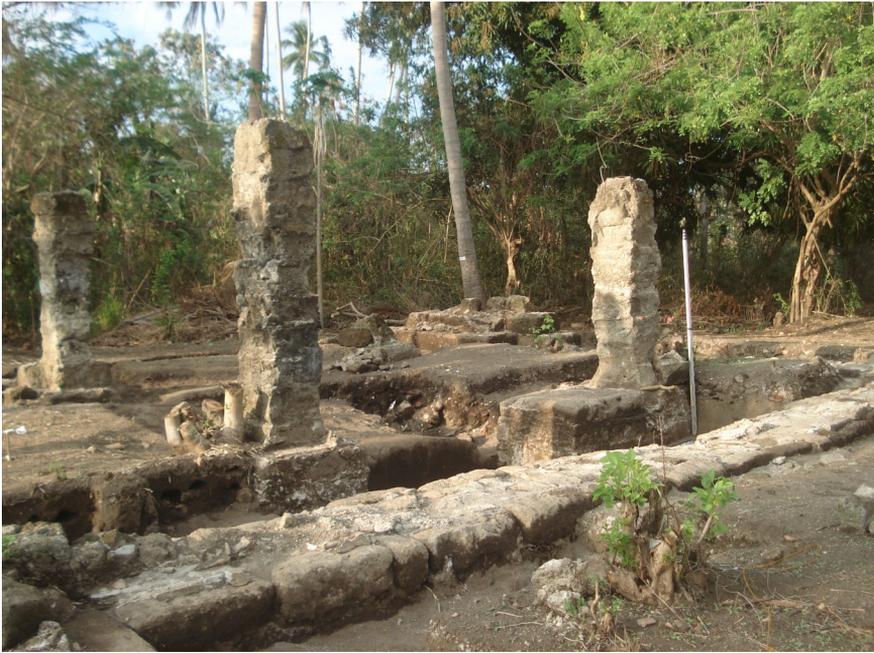
Figure 10: This is the eastern half of Structure B where remains (i.e. grout filling) of interior stone pillars and double walls are found.

1. Grout masonry is a “multi-unit construction in which the space between masonry units is solidly filled with grout” (Harris 2006: 480). Grout refers to mortar mixed with enough water to make it viscous enough, allowing it to be poured (Harris 2006). This kind of masonry was used for the construction of Structure B’s pillars, post bases, and double walls. For the pillars, stone blocks were laid out in a manner forming a square that is hollow in the middle. These blocks were bound by lime mortar, and every few layers, grout is poured into the hollow (Figure 13). A similar method was used for the construction of post bases. However, before the grout was poured, the wooden posts were probably first hoisted up and held in place. The grout, along with stone blocks, helped stabilise the wooden posts. For the double walls, stone blocks were laid side by side with a space in between. Again, these stone blocks are bound by lime mortar, and grout is poured after a few layers of stone blocks (Figure 10).

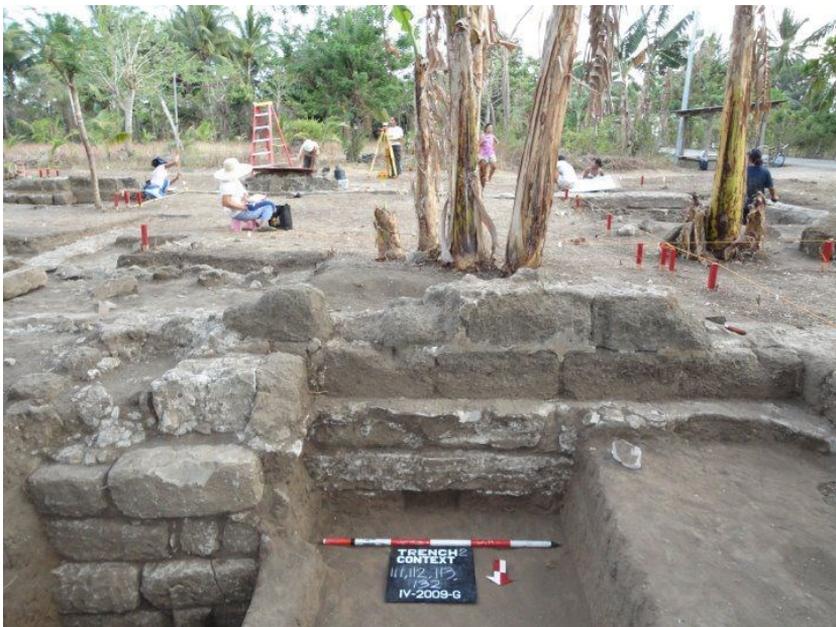
Figure 11: A portion of the north wall showing a post hole and post base and its foundation which used dry masonry; the only single wall in Structure B constructed through solid masonry. (Photo by M. Sy Cruz).

2. Solid masonry is a method used when masonry units (i.e. stone blocks) are placed directly adjacent to each other to form a solid load-bearing wall system (Ching 1991). It was used for the construction of a single wall in the northwest portion of the structure (Figure 11). Stone blocks were simply laid atop each other in a running bond pattern and bound by lime mortar.

3. Dry masonry is simply “masonry laid without mortar” (Harris 2006: 342). It does not make use of any kind of binding agent and depends largely on the fit of masonry units for its stability. This technique was seen utilised for the foundation of a post base along the northeast wall (Figure 11). The utilisation of rubble for one layer was noticeable in this post base foundation. This was also observed in the pillar foundation in Structure B’s southwest corner. Although lime mortar and cement were used to bind the stone blocks of most of the southwest pillar foundation’s layers, the penultimate layer was made of irregularly shaped stones with no visible binding agent. Dry masonry was also employed for the pavers on both the west and east sides. Stone blocks were laid directly on the sediment in a running bond pattern with no binding agent or mortar bed. The west and east pavers, however, were oriented differently. The pavers on the east

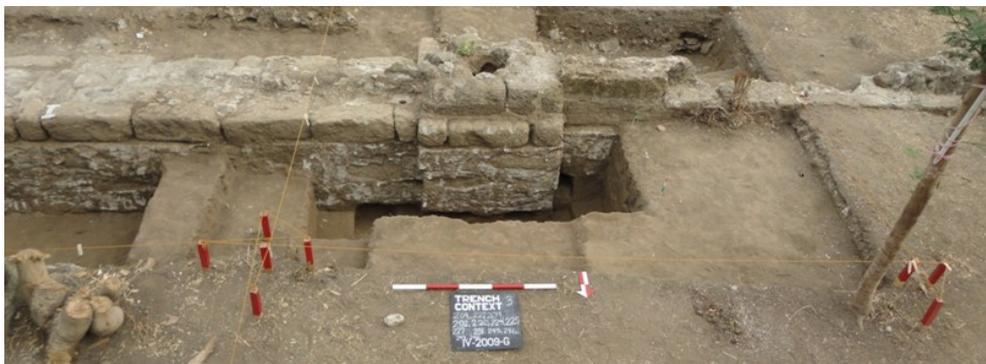
Figure 12: A portion of the structure's south wall found in Trench 3 exhibiting pronounced differences in wall construction.

Structure B had noticeable inconsistencies in its construction. Just along the south wall found in Trench 3, the double wall east of the exposed post base was 93 cm wide while the double wall directly west of it was only 55 cm (Figure 12). Further to the west closer to the southwest corner of the structure, the wall once again thickens to 62 cm at its widest. Such a drastic change in wall width was also observable along the north walls in Trench 2 (Figure 15).

Moreover, foundations of two post bases were looked into and it was found that they were constructed differently. The post base foundation along the south wall was constructed in the same way that the wall foundations were built (Figure 12).

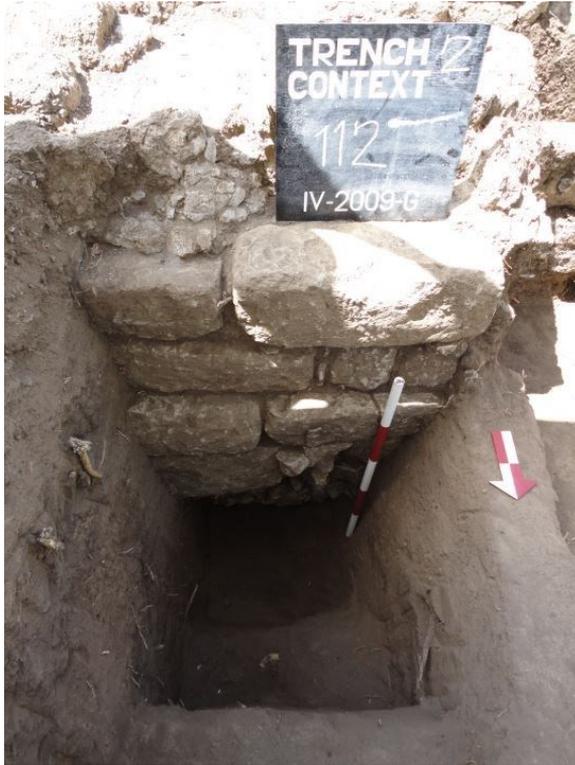
Figure 13: A post base foundation found along the structure's North wall in Trench 2.

The post base foundation along the north wall, however, was constructed similar to the southwest pillar foundation except that the post base foundation did not make use of any binding agent (Figures 13 and 14).

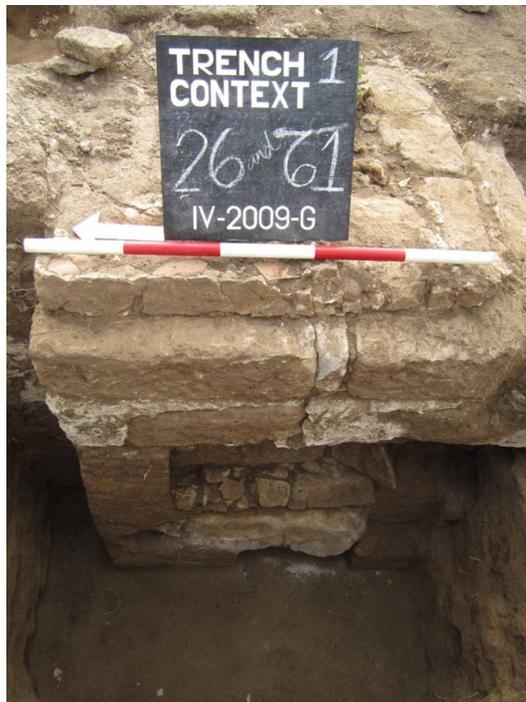
Figure 14: Ruins of a pillar, its base, and its foundation located in the structure's South-west corner in Trench 1.

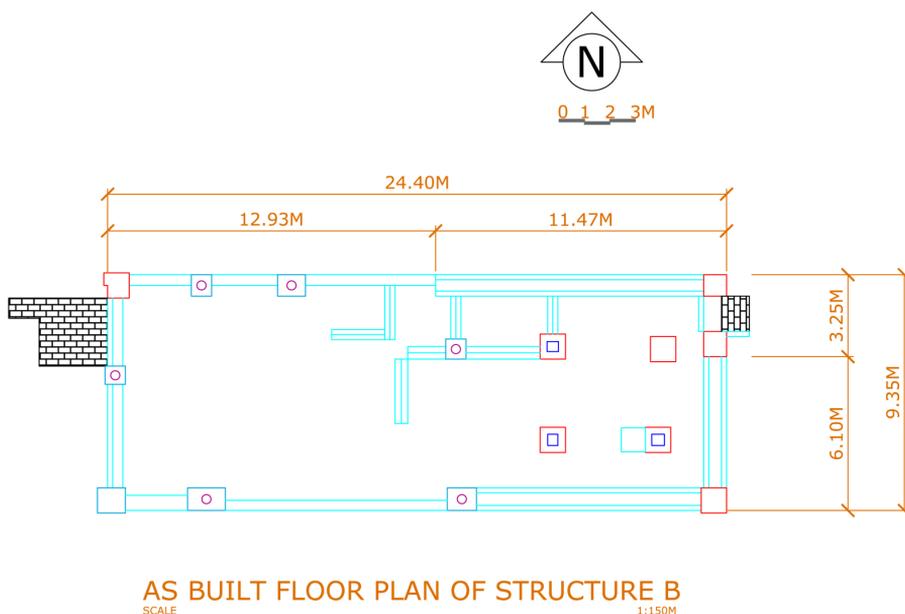
Figure 15: Structure B's floor plan based on the 2011 excavation (Prepared by Angel Sales from UP-ASP 2011).

were oriented north-south while those on the west had an east-west orientation (Figure 15).

Also noticeable was that pillars within the structure were present only on the eastern half (Figure 15). The only pillar present in the western half was located along the perimeter walls, specifically at the structure's southwest corner (Figure 15).

Another noticeable inconsistency is in the method employed in the building of walls during the second phase of construction. All of Structure B's walls were double walls except for a portion of the wall in the northwest found in Trench 2. A stretch of the north wall connected to the northwest corner was a single wall (Figure 15).
