Building in the Past: A Preliminary Analysis of the Construction Materials and Methods Used in Structure A in Barangay Pinagbayanan, San Juan, Batangas

The Batangas Field School Program under its field director, Grace Barretto-Tesoro, has been excavating Structure A, Site I in Barangay Pinagbayanan, San Juan, Batangas for two consecutive years. In 2009, the southern portion of Structure A was investigated which resulted to the discovery of parts of an old Spanish house more commonly known as bahay na bato. This Spanish house is believed to be made up of adobe blocks and wooden sidings with capiz windows and clay roof tiles. In 2010, the focus shifted from the southern portion of Structure A to its northern portion. The results from the 2010 excavation became a vital source of additional information about the whole structure. With the whole of Structure A almost excavated, a study of the construction technology employed to create the house should be done to further understand the structure. This paper will attempt to make such study. This paper will discuss the construction materials and technology used to build Structure A and compare it with other archaeologically investigated Sp

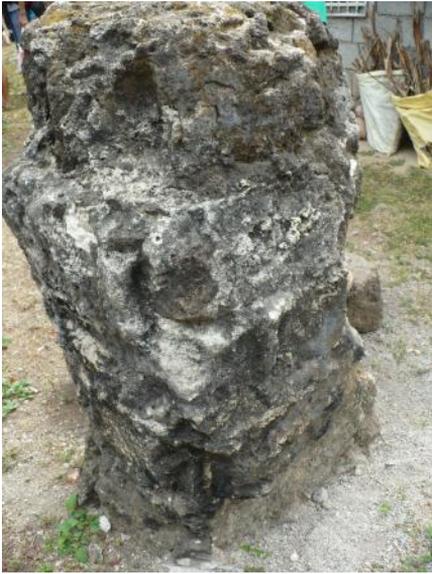
Figure 5: Stone column of Trench 7 (Photo by Riczar Fuentes).

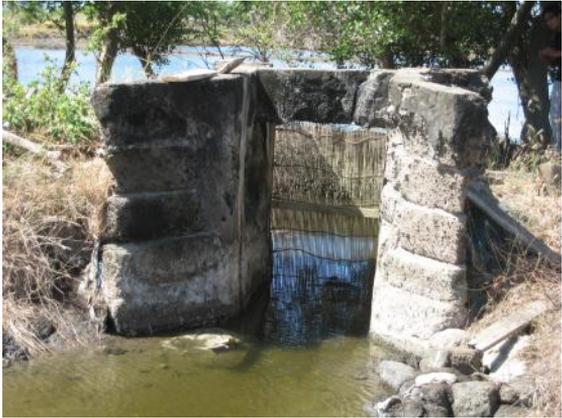
Figure 6: Recycled adobe blocks used in the town’s fish ponds (Photo by Riczar Fuentes).

Based on ethnographical accounts, adobe blocks were recycled by the locals to build fish ponds during the 1950s (Figure 6) and more recently as outdoor stoves or *tungko* used for food preparation during large celebrations (Barretto-Tesoro *et al.* 2009). The voids left by the adobe blocks caused the irregularity in the size of the columns. The stone columns, based on the earthquake ordinance of 1880, may have had a height of 280 centimetres and did not continue to the second-floor. Instead, wooden posts made of Philippine hardwood such as *molave* may have been used to support the roof and walls of the second storey. The height of the ground floor columns were based on the inferred height of the ground floor walls which will be discussed in the next section.

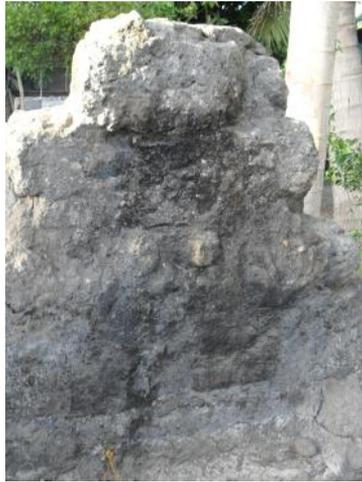
Figure 7: Northern exterior wall of Structure A viewed from the inside of the structure (Photo by Angelus Sales).

The exterior walls and interior partition walls of the ground floor were made of adobe blocks (Figure 7). Blocks measured from the two previous excavations have varying dimensions. One whole block from the 2010 excavation has a length of 72 centimetres, a width of 28 centimetres, and a height of 28 centimetres while a complete block from the 2009 excavation was 76 centimetres long and 28 centimetres wide. The walls of the ground floor area of Structure A have an approximate thickness of 56 centimetres and a height of 280 centimetres. The height of the walls was estimated based on the earthquake ordinance's prescribed thickness of the walls which should be a fifth of the height of the wall. Since the thickness of the walls was known, the height was simply calculated based

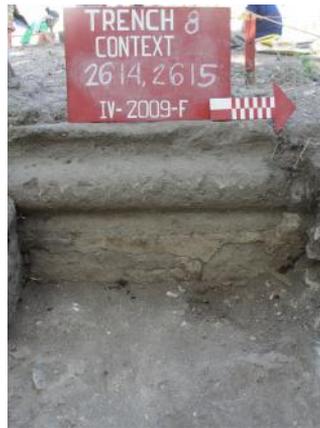
Figure 8: Decorative mouldings found in the eastern exterior wall (Photo by Marie Louise Antoinette Sioco).

Decorative mouldings were also used for the exterior walls to delineate the base of the exterior walls from the ground surface (Figure 8). The mouldings have a length of approximately 75 centimetres and a height of 30 centimetres. These mouldings were made from a mixture of lime cement or what is locally known as *apog*, sand, water, and very small gravel-like stones. Pilasters were also used for the exterior columns. Pilasters are columns that are embedded in a wall and are protruding from one or both faces of the wall. In the case of Structure A, the pilasters are protruding from only one face of the wall which was the exterior side of the structure (Ching 2008).

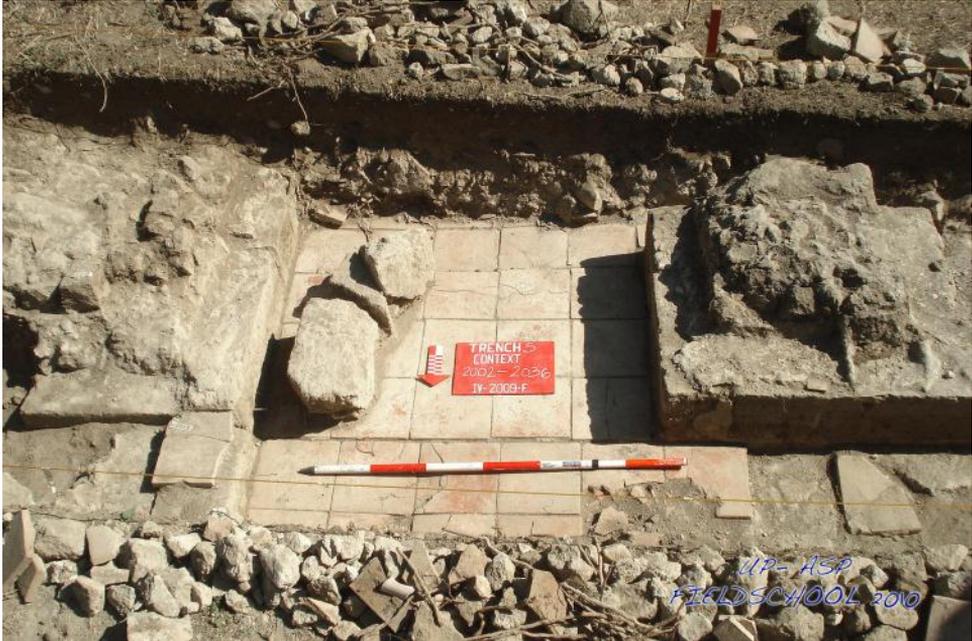
Figure 9: Baldosa found in-situ in Trench 5 (Photo by Noel Amano and Kate Lim).

The flooring material for the ground floor area of Structure A was quite varied. In the northern portion of Structure A, clay tiles or *baldosa* was used to finish the floor surface of the area occupied by Trench 5 and 7. This was based from the *baldosa* found in-situ in Trenches 5 (Figure 9) and from the *baldosa* impressions found on the mortar floor of Trench 7. The *baldosa* that was found in-situ measured 28 centimetres long and 28 centimetres wide. Adobe blocks were also found in-situ in Trench 4 (Figure 10) at the southern portion of Structure A. The adobe blocks served as pavers for what was believed to be a storage area for rice grains (Barretto-Tesoro *et al.* 2009). Compacted dirt floor was also used in some areas of the ground floor as indicated by the very compact dark reddish brown layer encountered during the excavations. Different flooring materials were used in the ground floor of Structure A to signify change in the function of the space and also to denote hierarchy of space.

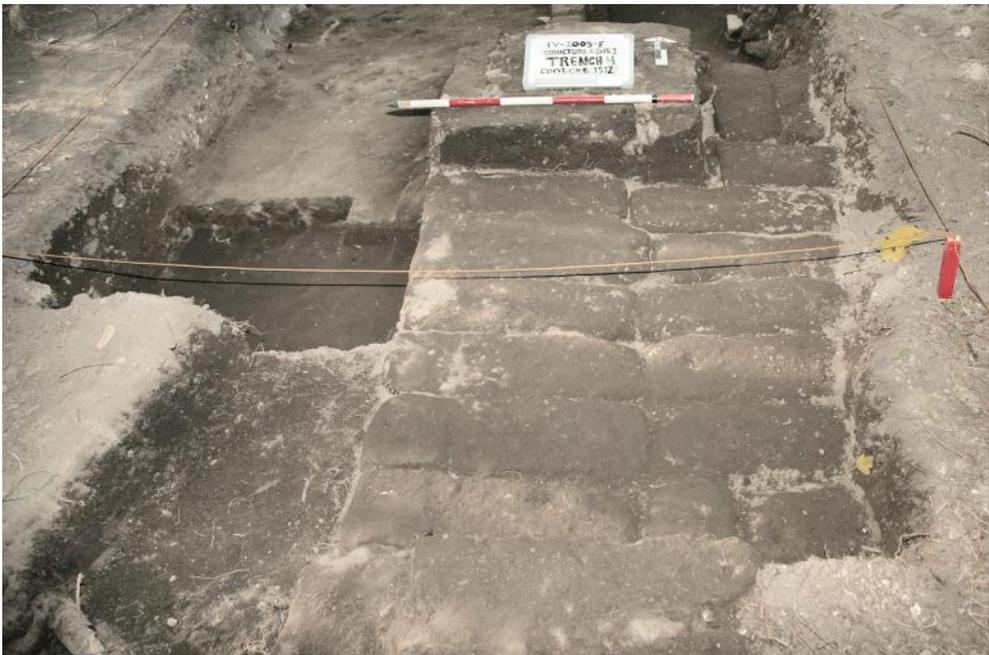
Figure 10: Flooring made of adobe blocks found in Trench 4 (Photo by Archie Tesoro).

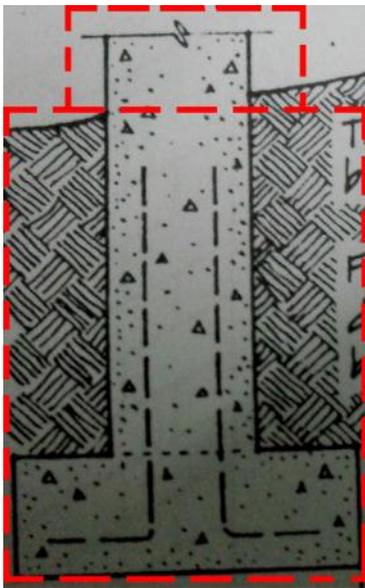
Figure 11: An illustration of a modern spread footing foundation. (Source: Building Construction Illustrated, 2nd edition. This material is reproduced with permission of John Wiley and Sons, Inc.). The red dash lines are outline of the spread footing used for Structure A.

The type of foundation used was a spread footing foundation (Figure 11). A spread footing foundation is a kind of foundation that uses a “pad” to spread the weight of the building over a sufficiently large soil area (Fajardo 2001). Two different types of spread footing foundation were used in Structure A. The wall foundation was constructed using a strip footing while the column foundation made use of isolated footing. A strip footing is a continuous spread footing used mainly for wall foundations while isolated footing is a single spread footing that supports a column (Ching 1995).

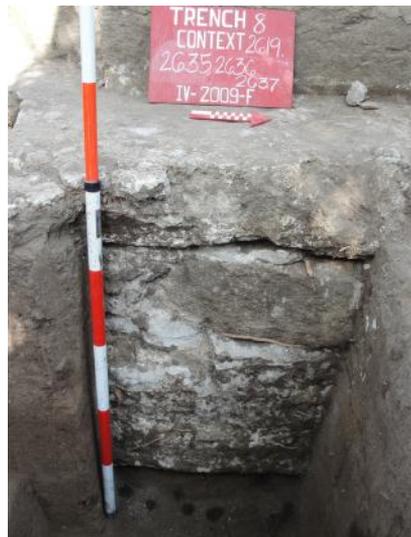
Figure 12: Actual photo of a foundation located in Trench 8 (Photo by Marie Louise Antoinette Sioco).

At the time Structure A was constructed, the use of metal reinforcements was not yet widely practiced. As such, a foundation greatly depended on its sheer massiveness and depth for stability and strength (Figure 12). The thickness of the foundation of Structure A was varied. Column foundations were thicker and therefore, much deeper than wall foundations. The column foundations were more than a meter thick such as those in Trench 6 (100cm) and Trench 10 (180cm). The base of the column which was connected to the foundation was more than a metre wide.

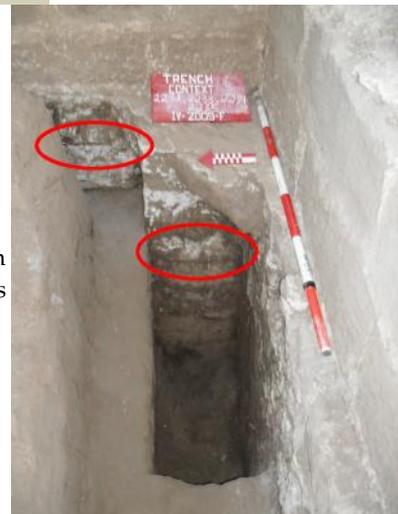
Figure 14: Actual photo of an excavated foundation in Trench 6. Red circles show the plank impressions found on the foundation (Photo by Angelus Sales).

To be able to build the foundation, formworks were needed to mould the foundation. Formworks used for Structure A were wooden planks that were joined together. Once joined together, the mixture of lime, sand, and water were poured unto the formworks to create the foundation (Figure 13). The use of wooden planks as formworks were indicated by the plank impressions found on the excavated foundations (Figure 14).

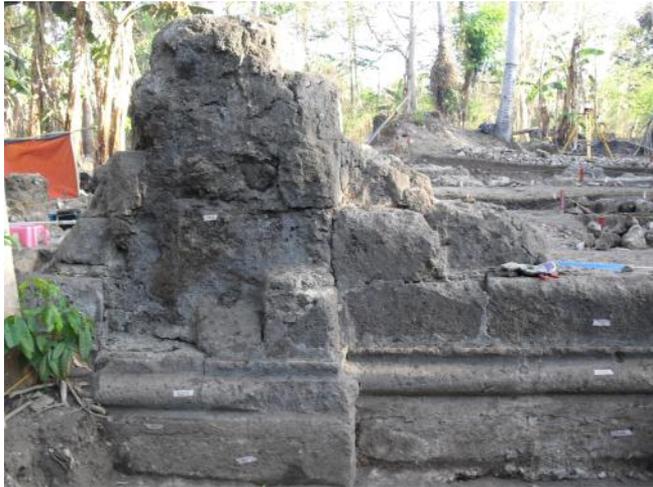
Figure 20: Actual photo of the northern exterior wall found in Trench 10 (Photo by Angelus Sales).

The exterior and interior partition walls were constructed using adobe blocks that were laid out in a side by side fashion forming a double wall which makes the walls very thick (Figures 19 and 20). In between the adobe blocks were the lime mortar binding the blocks together. No metal reinforcements were used since the practice of putting reinforcements in walls was not yet known to every master builder. Common bond was used as a method for laying the adobe blocks. Common bond or also known as stretcher bond is the typical method of brick laying. With this method, the blocks are laid on its bed showing the stretcher face or sides of the block. Bed is the term used to refer to the top and bottom surfaces of a brick or block (Fleming 2005). The mouldings that were used for decorative purposes were made with the use of formworks from which the lime mortar mixture was poured unto.

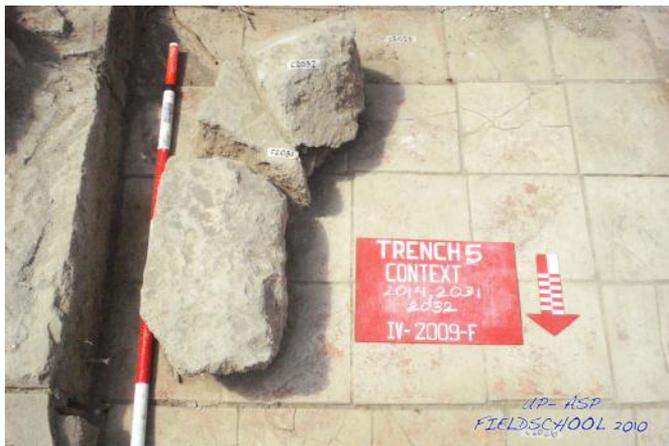
Figure 21: Arch debris found in Trench 5 excavated during the 2010 excavation (Photo by Noel Amano and Kate Lim).

The mouldings must have been built on the construction site itself. The double wall system is the preferred construction method of the Consultative Council of Public Works which issued the Earthquake Ordinance of 1880 (Zialcita and Tinio 2002) Arches were also used for the doorways of the ground floor area. Arches are curved structures used primarily for wall openings. The use of arches in Structure A is indicated by the excavated debris of fallen arches. Voussoirs were found in Trenches 3 and 5 (Figures 21 and 22) while a keystone was found in the trench extension of Trench 7. Voussoirs are the wedge-shaped portion that comprises an arch while a keystone is a type of voussoirs that is found in the middle of the arch. Adobe blocks were worked by stone masons to form pieces of the arches.

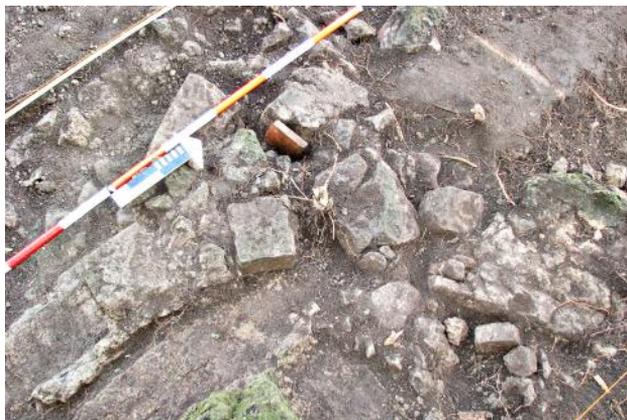
Figure 22: Arch debris found in Trench 3 excavated during the 2009 excavation (Photo by Archie Tesoro).

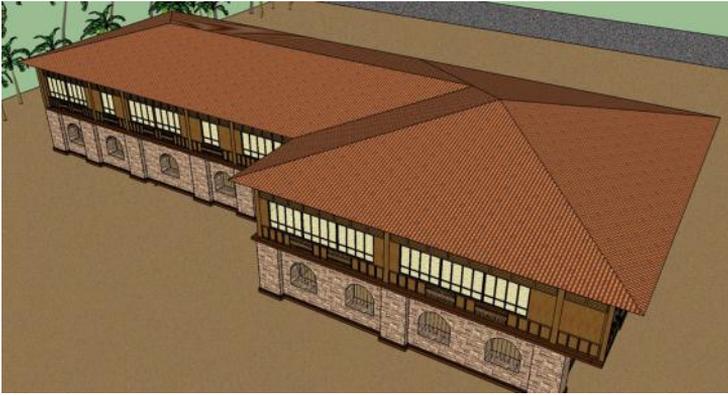
Figure 27: A 3d modelling of Structure A showing the hipped roof (Illustration by Mary Nolyn Ventura).

For the roof of Structure A, a hipped roof construction may have been used as this was the typical roof typology at that time (Figure 26). A hipped roof is a type of roof construction where all its four sides are sloping (Figure 27). It is also known as *quarto aguas* in the local language. This type of roof construction is quite common even today because it is considered as the most stable of roof types and cannot easily be uplifted by strong winds especially if constructed properly. The roofing members must be made of thick lumber to adequately support the heavy clay roof tiles and usually joined together by bolts. Wooden posts connected to the stone columns were used for the upper floor to support the weight of the entire roof structure.

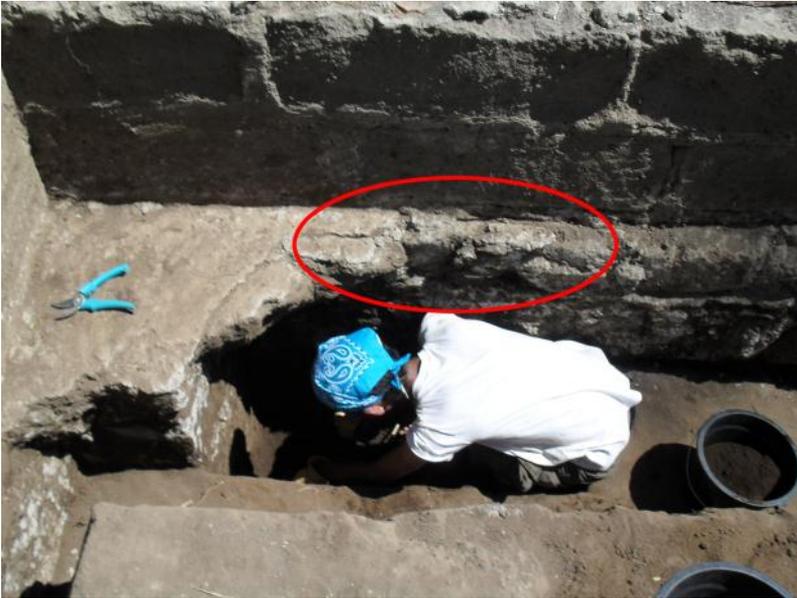
Figure 28: Encircled portion in the photo is the crumbling lime mortar foundation (Photo by Angelus Sales).

Another inconsistency in the structure is that some of the foundations were poorly constructed and the materials used were not consistent such as the case of the lime mortar foundation found in Trench 6 (Figure 28) which was crumbly and the use of adobe block in the foundation of Trench 8 (Figure 29). These inconsistencies may be brought about by poor craftsmanship in some of the workers. It is also possible that the workers may have skimmed on the lime and added more water than usual which resulted to a brittle lime mortar foundation. The consequence of lessening the lime in a lime mortar mixture is that it lessens the compressive strength of the lime making it susceptible to brittleness and crumbling. The materials may have also run out while construction was on-going resulting to substitution of other materials. Master builders at that time do not have knowledge of standard cost estimating procedures that architects and engineers of today have. They rely on previous experiences to calculate how many materials were needed (Zialcita and Tinio 2002).

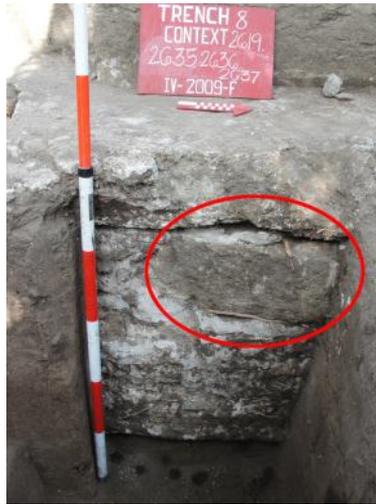
Figure 29: Encircled part is the adobe block used for the lime mortar foundation (Photo by Marie Louise Antoinette Sioco)

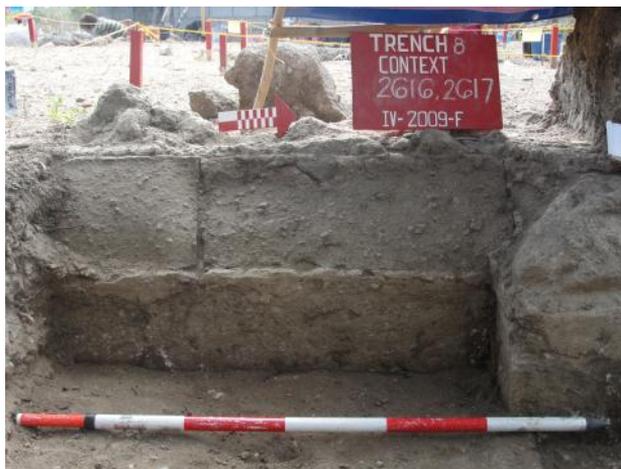
Figure 30: Chipped-off moulding found in Trench 8 (Photo by Marie Louise Antoinette Sioco).

One more noticeable anomaly in Structure A is the mouldings found in Trench 8. The mouldings in Trench 8 do not look the same. The mouldings that looked different from the rest of the mouldings found in Structure A seemed to have been chipped off (Figure 30) but this hypothesis is still being debated. The people who worked on Trench 8 argued that it may not have been a moulding at all because of the unusual angle of the supposed chipped moulding. But based on ethnographical accounts, there are clear evidences that the mouldings may have just really been chipped off to be used as building blocks for making other structures in town. A case in point is the storage area used for rice milling machines (Figures 31 and 32).

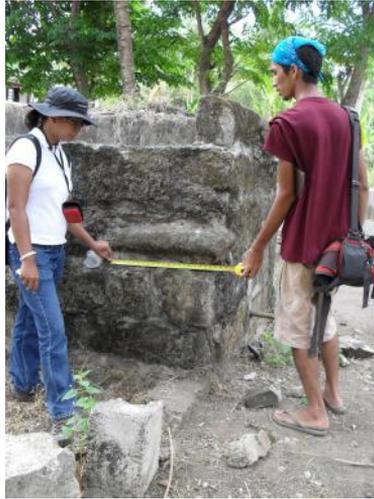
Figure 31: Storage structure for rice milling machine that made use of a moulding (Photo by Angelus Sales).

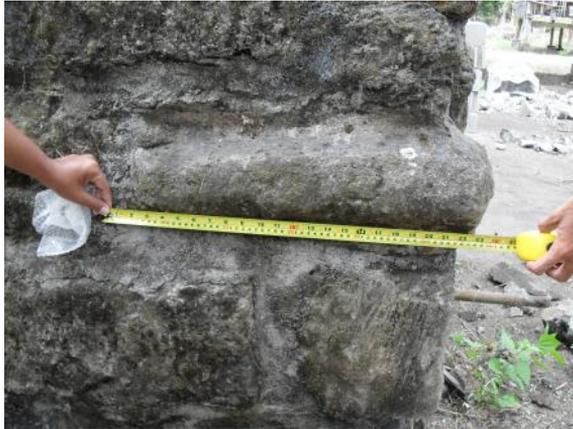
Figure 32: Close up photo of the chipped moulding used as part of the wall of the storage structure (Photo by Angelus Sales).
