FORENSIC EVALUATION OF TEMPERATURE HISTORY FOR FIRE-DAMAGED CONCRETE USING AN ORDINARY DIGITAL CAMERA: CASE STUDY OF THE BURNED PALMA HALL PAVILION II, UP DILIMAN

Diocel Harold M. Aquino
Benito M. Pacheco
Nicole C. Miranda

Institute of Civil Engineering, University of the Philippines Diliman

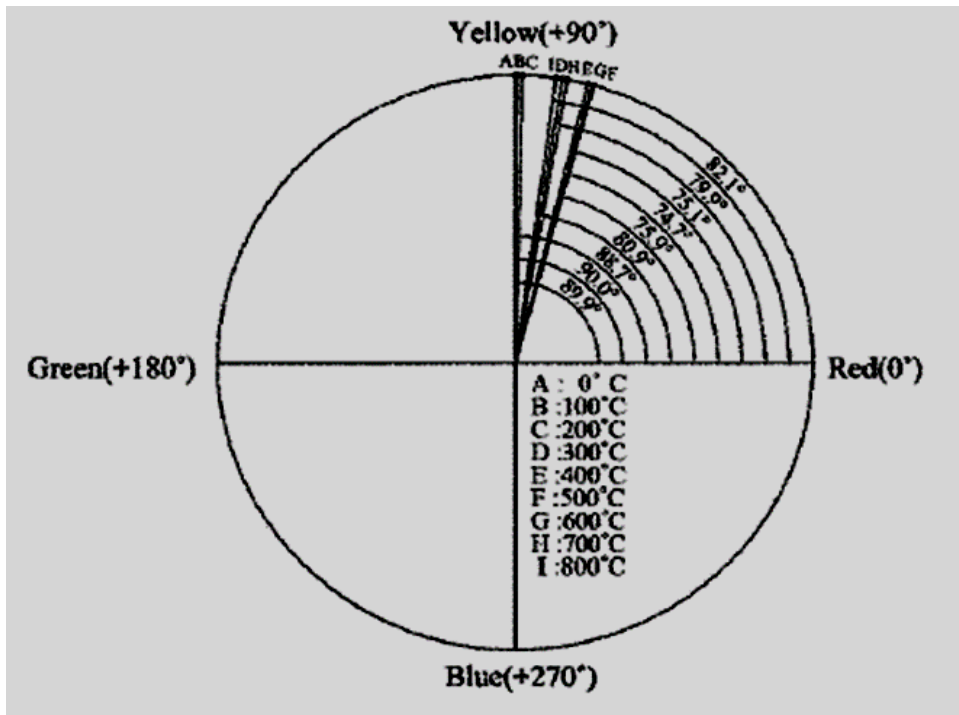
Figure 2. Hue Angle Changes by Temperature expressed in L*C*h (w/c = 0.55) (Lee, Choi, and Hong, 2009) [Korea]

Concrete samples were exposed to temperatures ranging from 100°C to 700°C, in increments of 100°C. The RHV was taken with respect to a sample exposed to a temperature of 20° C. Figures 1 and 2 illustrate the effect of elevated temperature on concrete color, expressed in L*c*h color space, for w/c = 0.45 and w/c = 0.55 respectively. The average to correspond to w/c=0.5. The calibration scale derived from this study is shown graphically in Figure 3.

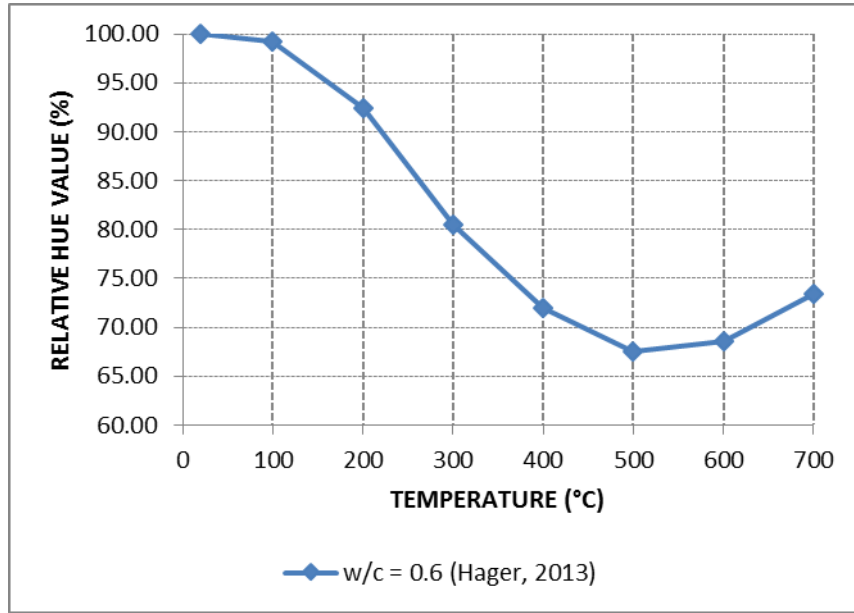
Figure 5. Relative Hue Value (%) versus Temperature Calibration Scale from Hager, 2013 [Poland]

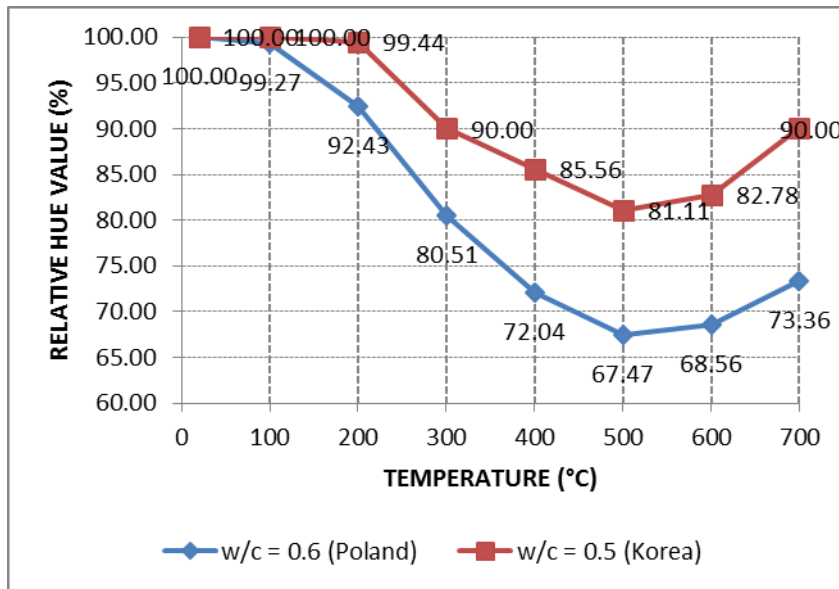
The two calibration curves were superimposed as shown in Figure 6. The curve derived from Hager’s work is significantly lower than that from Lee’s.

Figure 6. Superimposed calibration curves from Lee’s (Korea) and Hager’s (Poland) studies

Portland cement type 1, which is the most commonly used cement in general construction, was used in the study of Lee. On the other hand, CEM II/A-V 42.5R, consisting of 80-94%

Portland cement clinker and mixed with fly ash, was used in Hager's study. Fly ash refers to the residues produced during the combustion of coal that rise with the flue gases. This material predominantly consists of silicon dioxide (SiO_2) with some other compounds found in ordinary Portland cement. It is assumed that the fly ash component does not significantly affect the color change in the concrete. Further, relative hue values are taken in lieu of the absolute hue values, to normalize and take into account the difference in the amounts of the compounds that respond to temperature change.

In terms of the concrete composition, the variation in the water-to-cement ratio could have caused differences in the color change in response to the rise in temperature.
